Flooding in Dolgellau, Saturday 15 January 2011

The sequence of photographs below, taken around 11am, demonstrate flood routing:

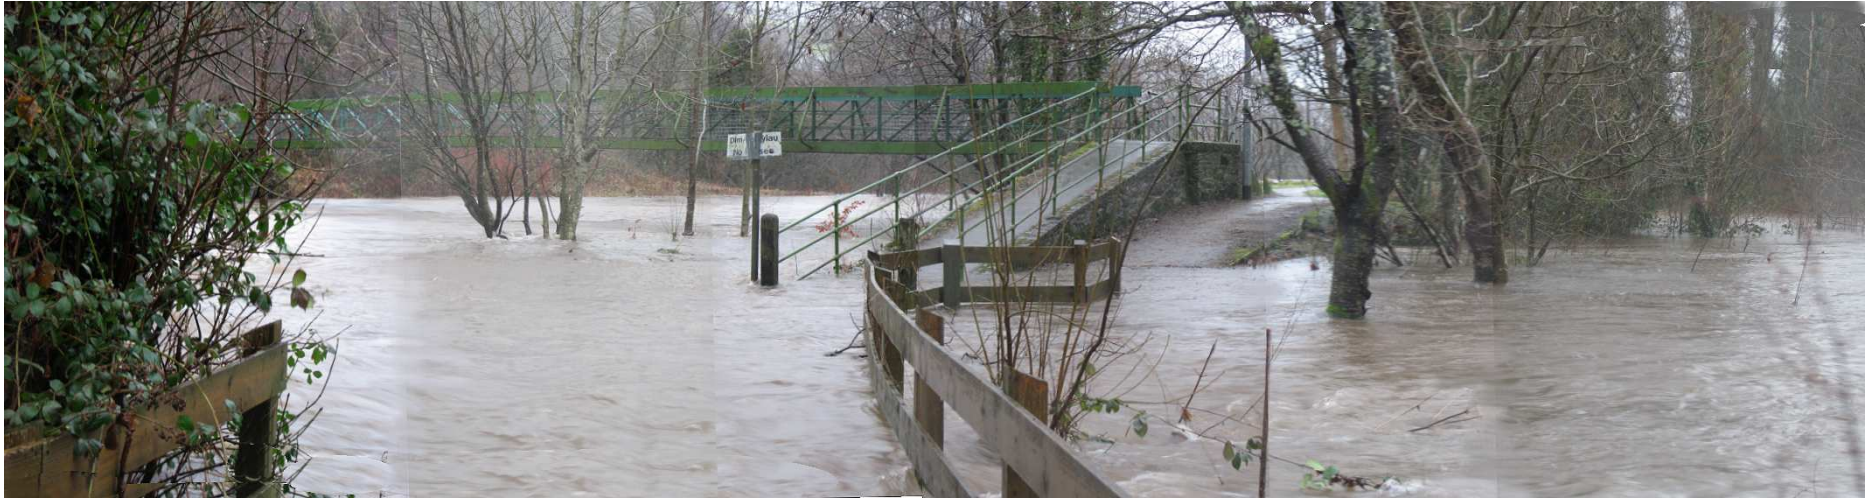
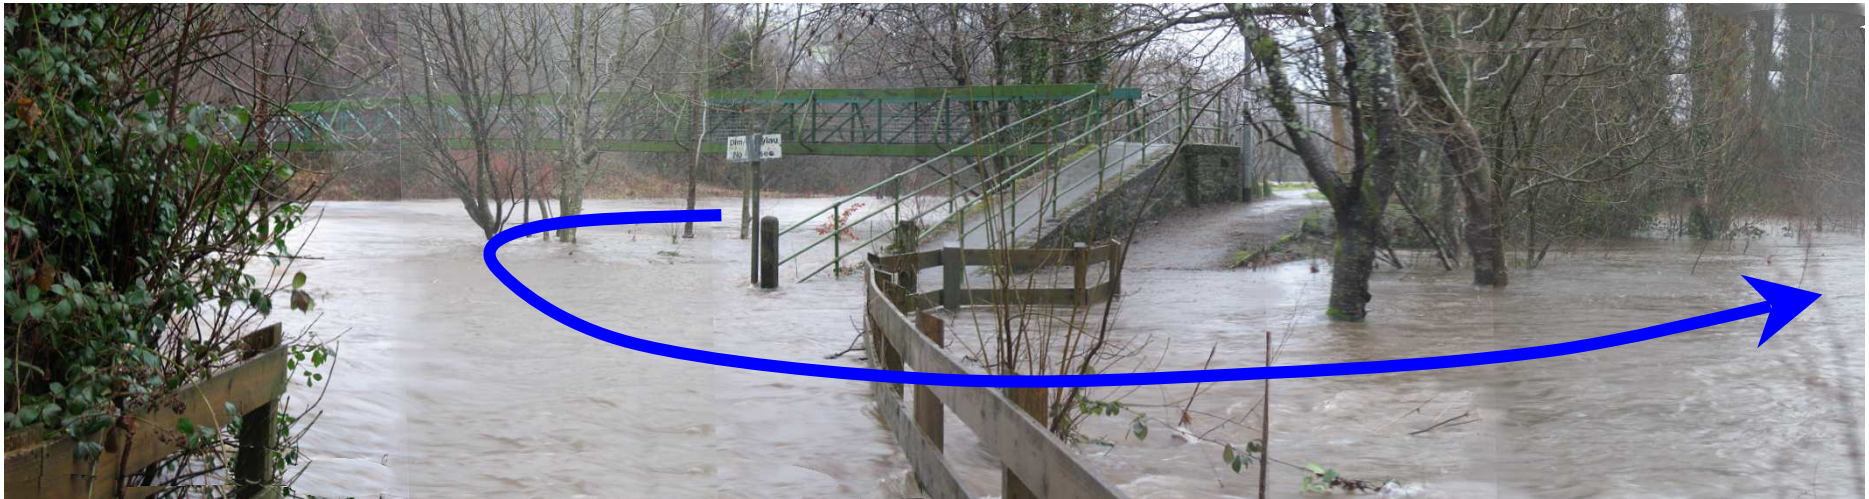
Figure 1: Confluence at Pandy'r Odyn.

Floodwater is seen to be entering the Marian Mawr fields from the western end. Flow volume is enormous.

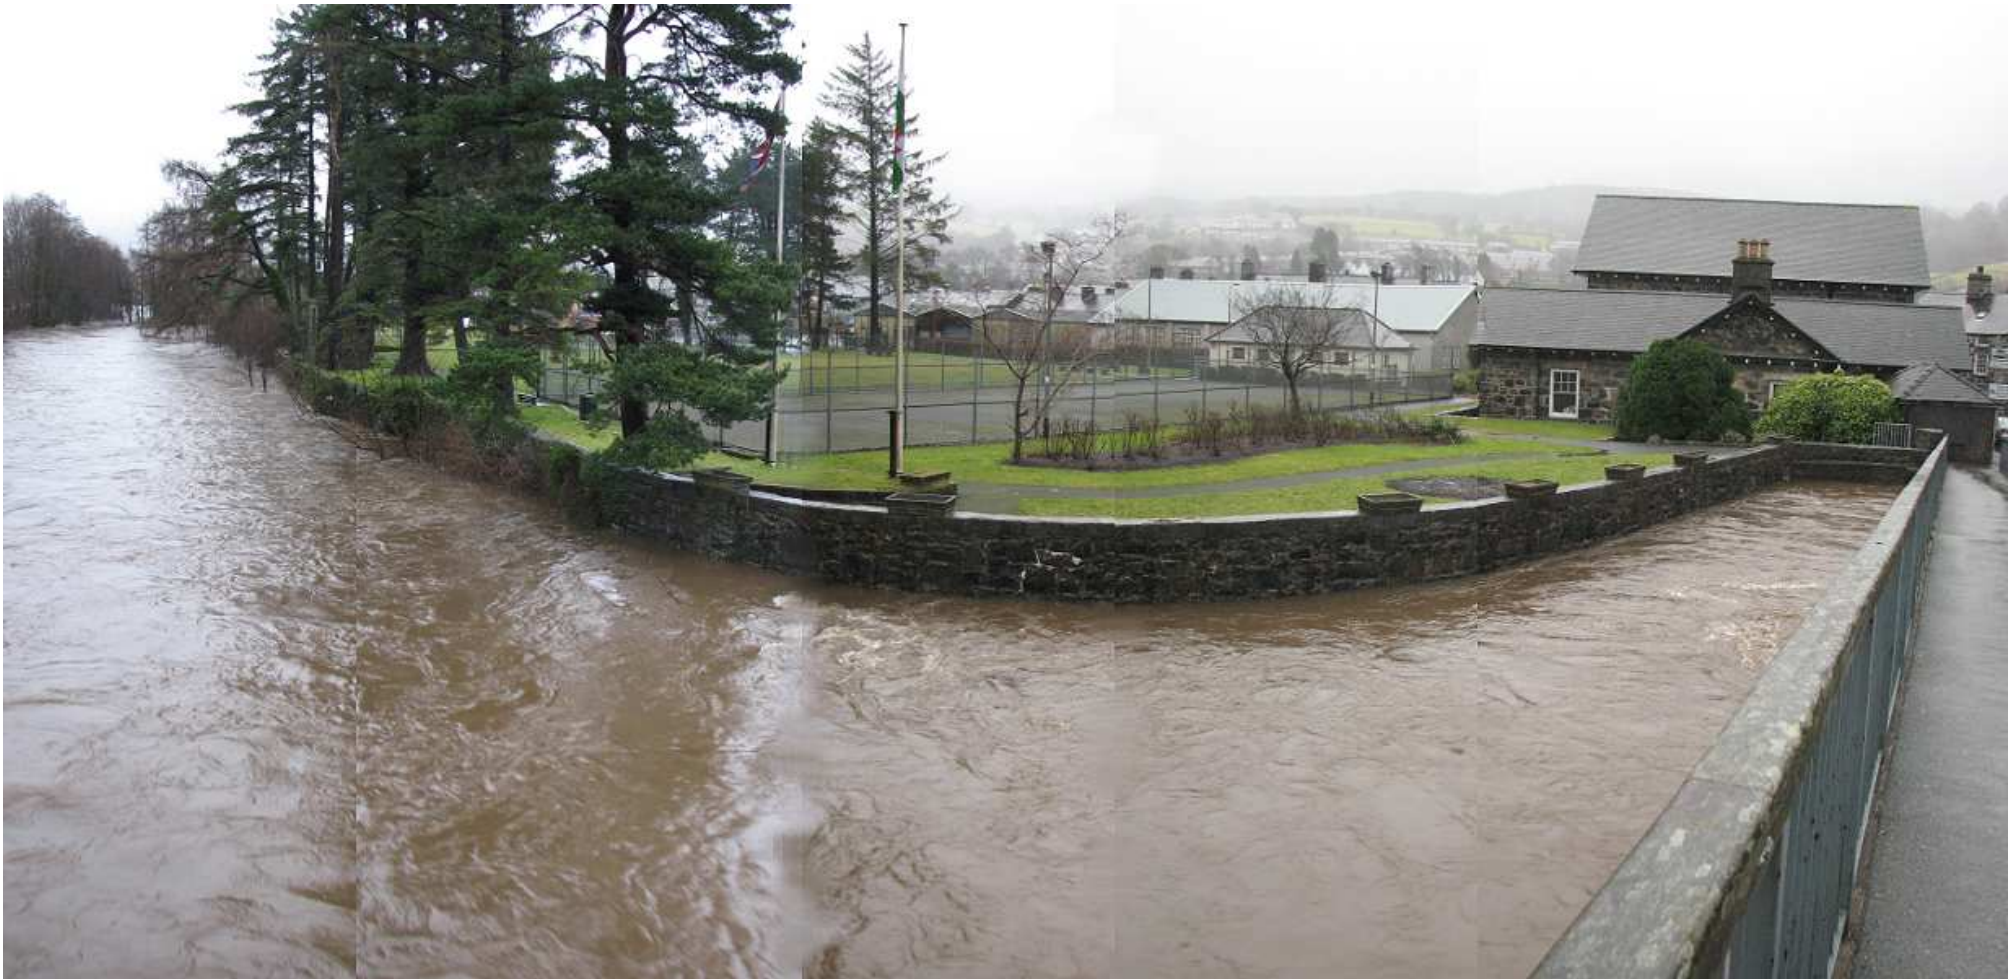
Figure 2: Afon Wnion upstream from Bont Fawr.

The high river walls are very adequately protecting the park from flooding.

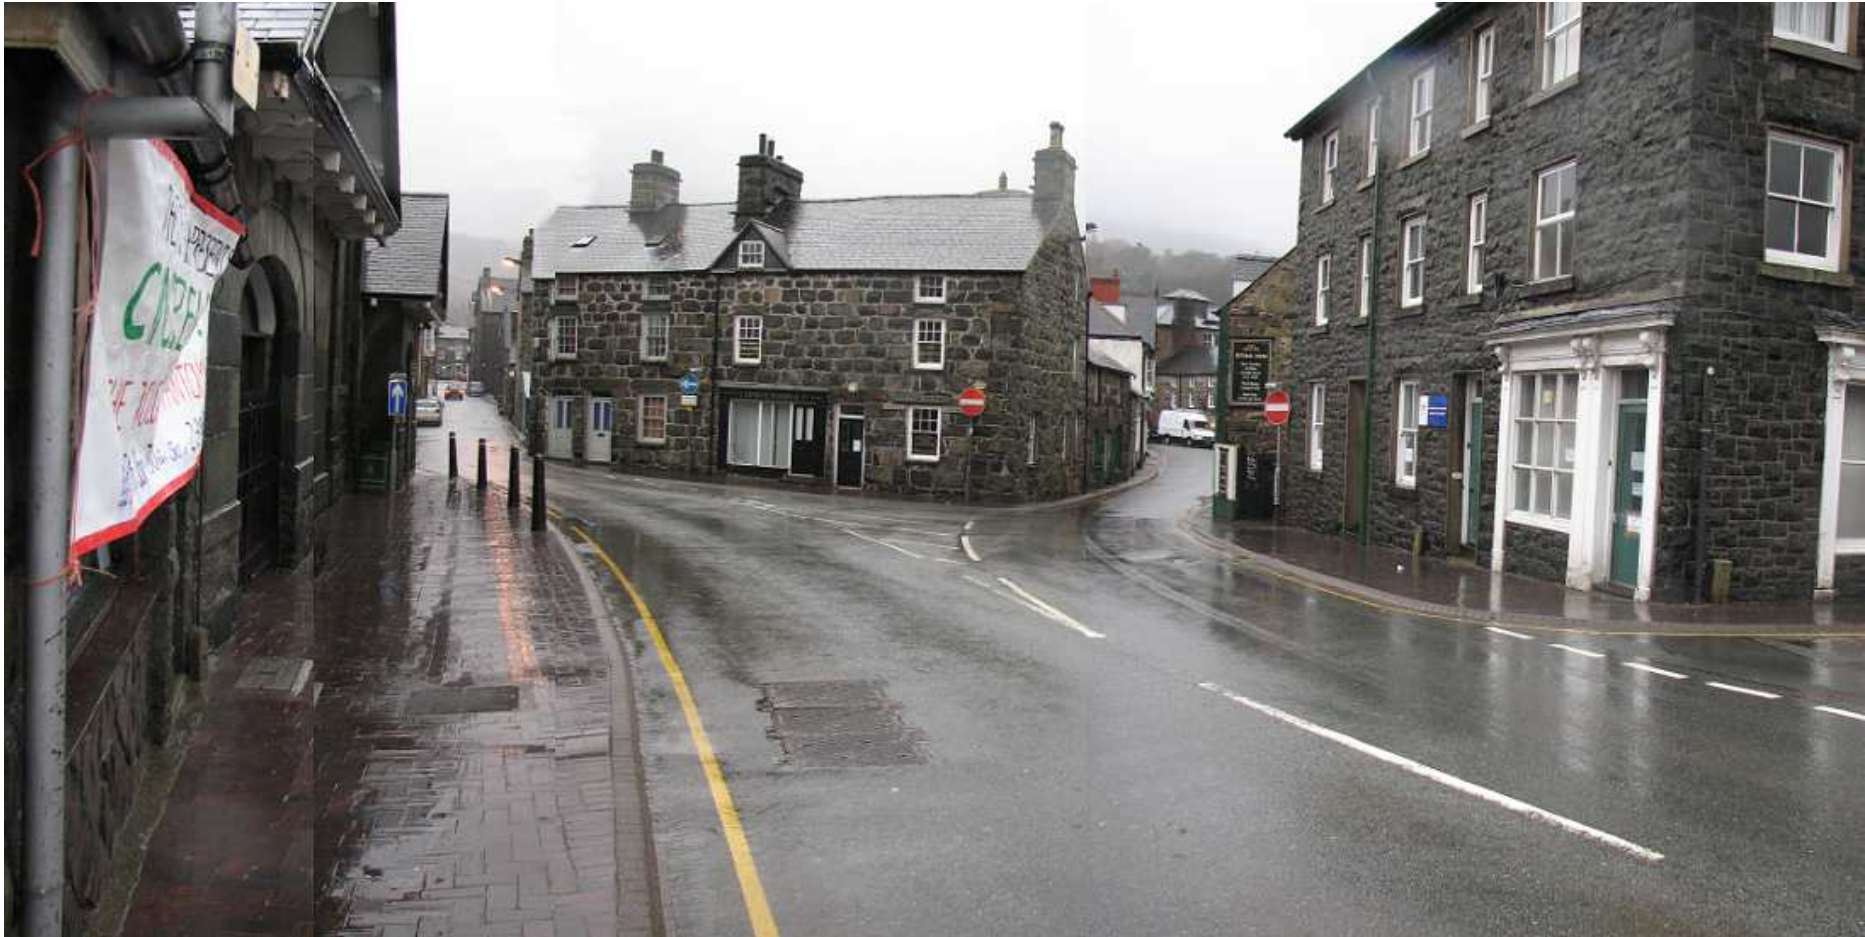
Figure 3: Streets leading into Dolgellau from Bont Fawr.

It is noticeable from the orientation of building features that Ffos y Felin (to the left) slopes upwards from this point, whilst Bridge Street (to the right) initially slopes downwards following a presumed former course of the Arran stream.

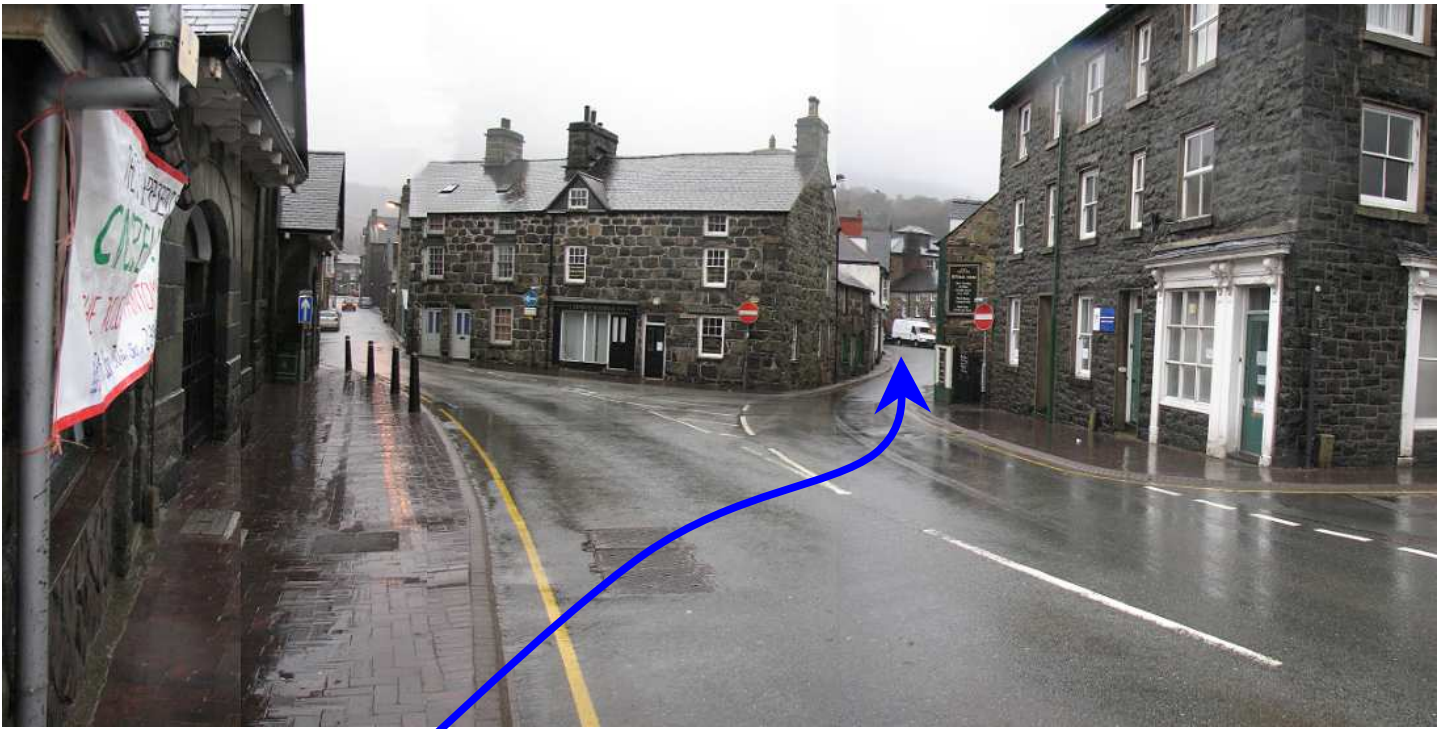
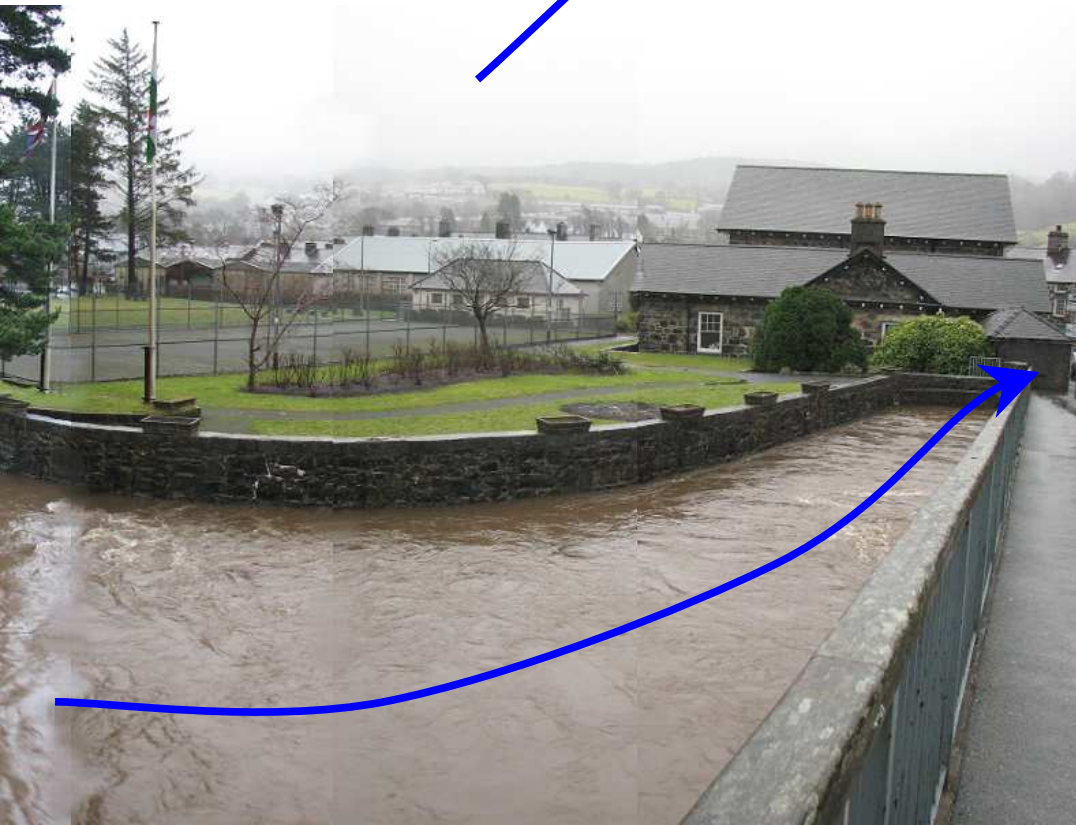
Figure 4: The route of highest risk for flooding of properties in Dolgellau is shown above. This involves water breaching the wall at the end of Bont Fawr and flowing down hill past the Court Building into Bridge Street. Indeed, as these pictures were being taken, a Council lorry loaded with sand bags arrived to reinforce this section of wall.

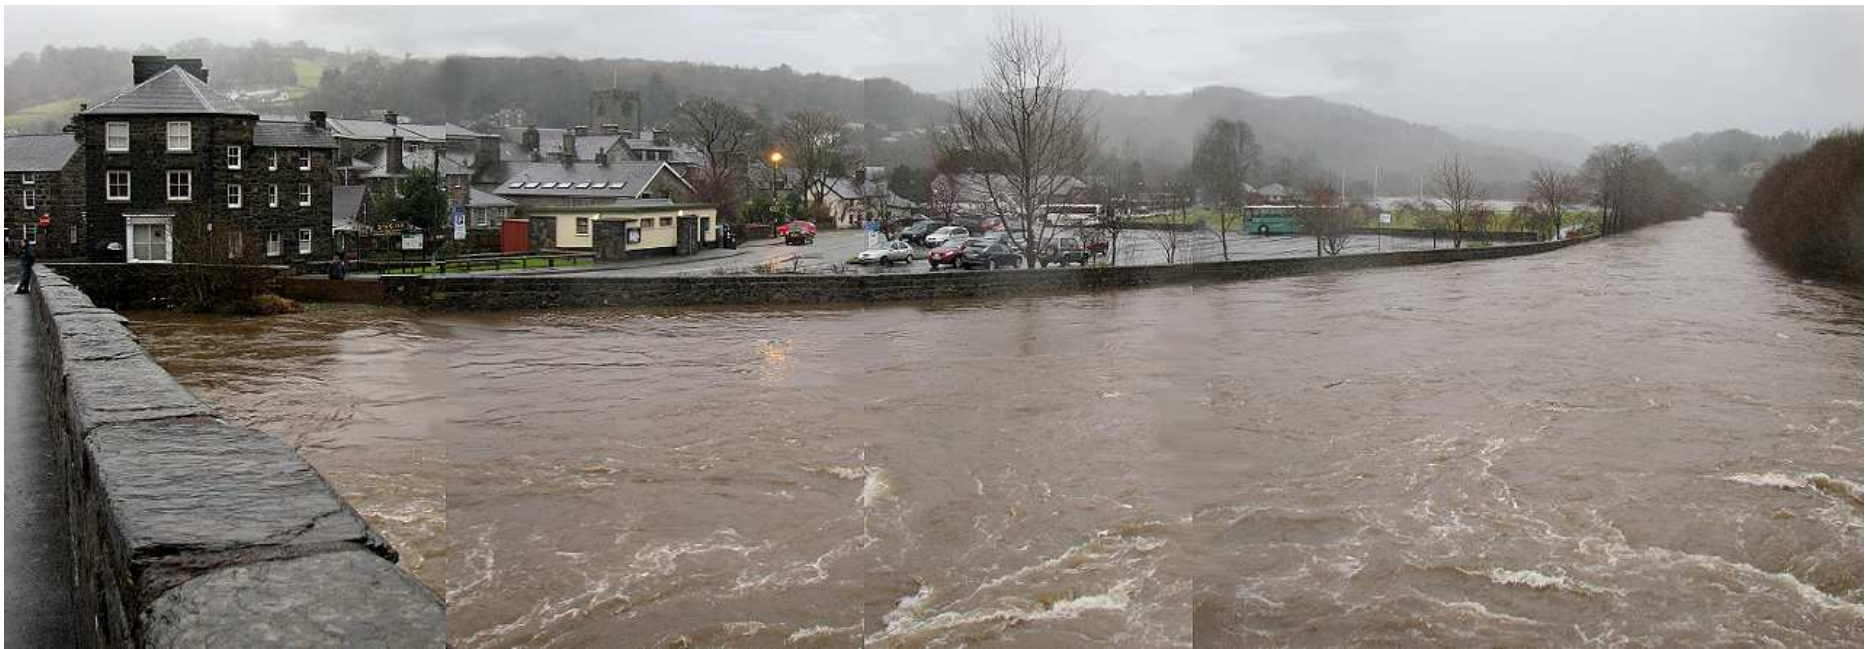
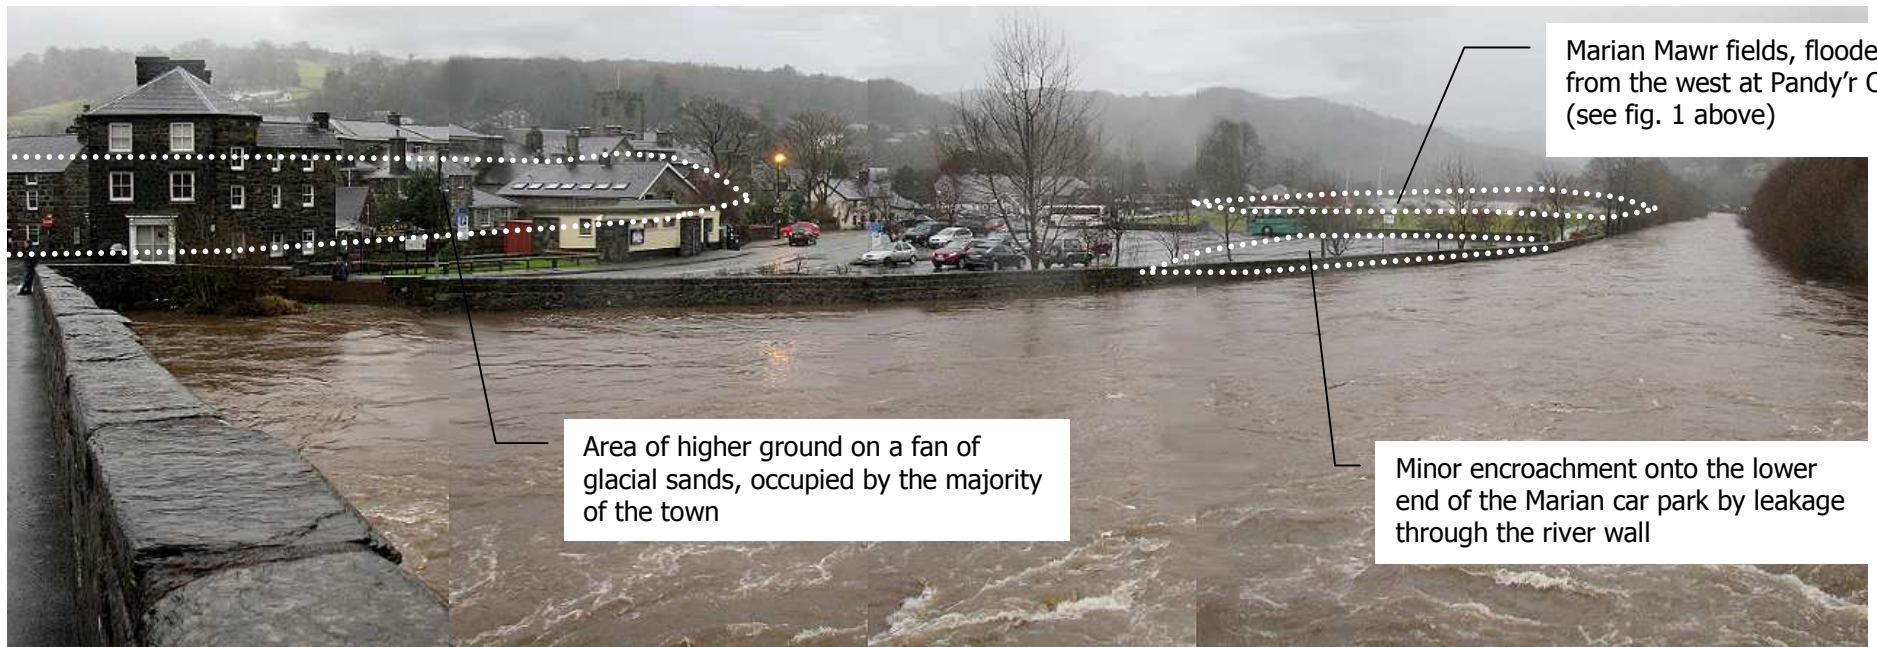
Figure 5: The Afon Wnion, looking downstream from Bont Fawr

Marian Mawr fields, flooded from the west at Pandy'r Odyn (see fig. 1 above)

Area of higher ground on a fan of glacial sands, occupied by the majority of the town

Minor encroachment onto the lower end of the Marian car park by leakage through the river wall

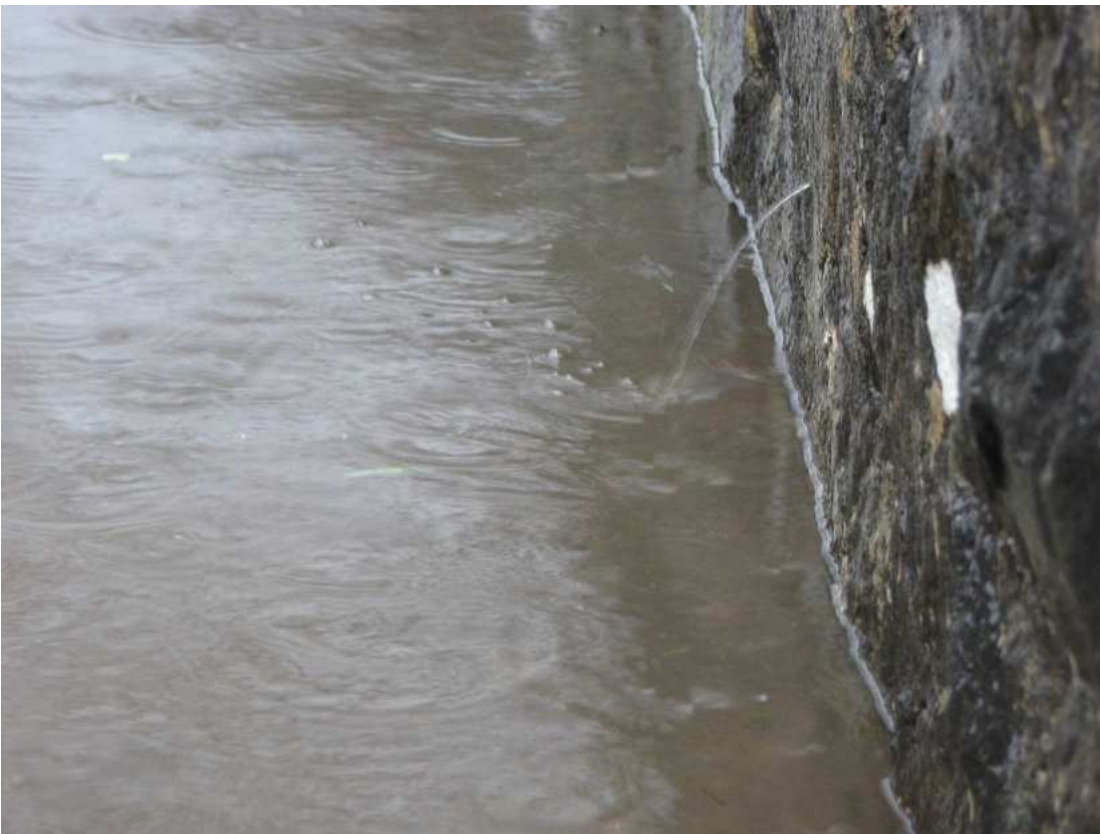
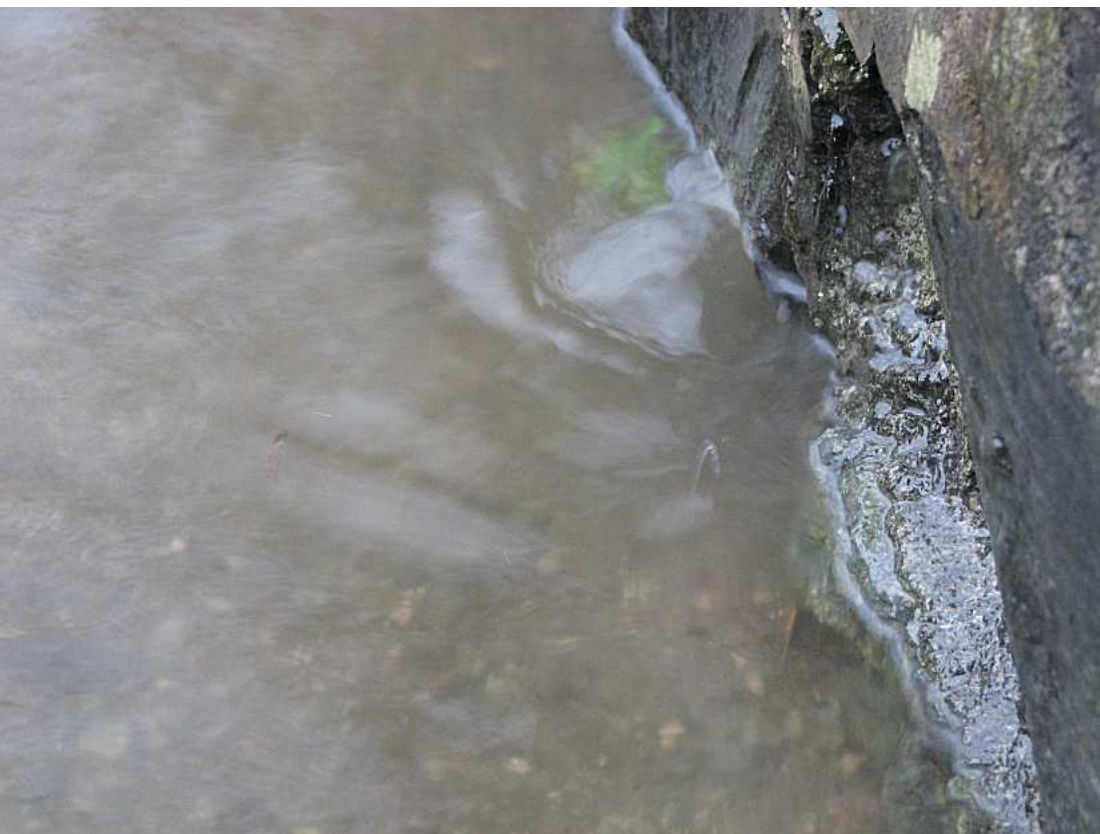
Figure 6: Leakage of flood water through the river wall at the Marian car park

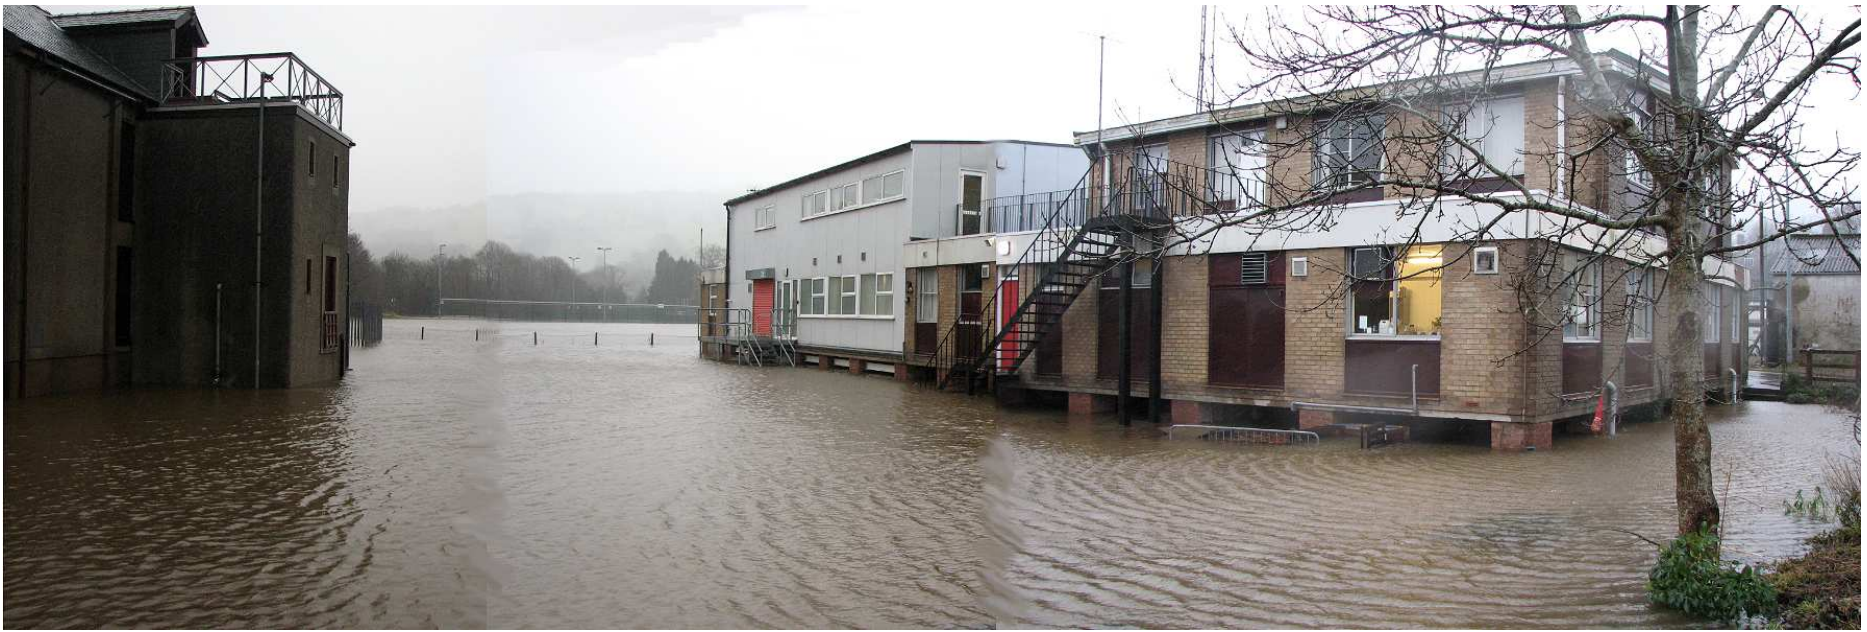
Figure 7: Extensive flooding around the Fire Station, Arran Road

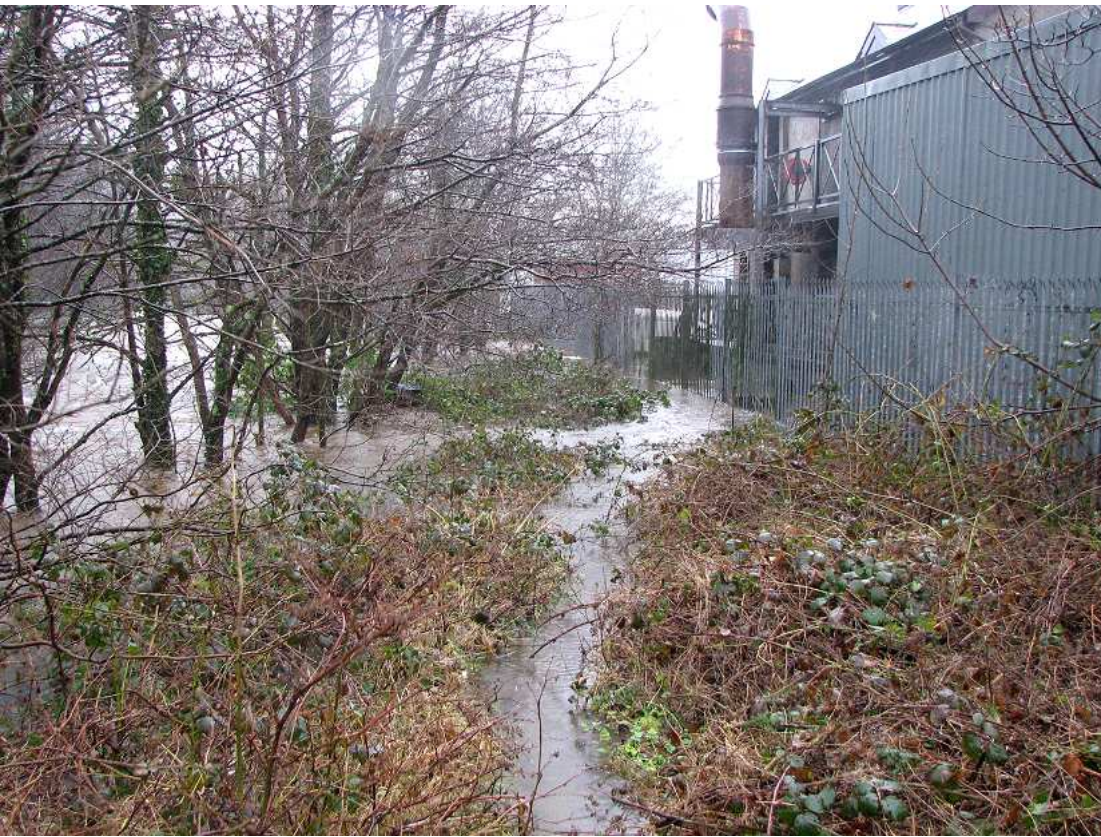
Figure 8: Flood waters overtopping the riverbanks upstream from the Fire Station

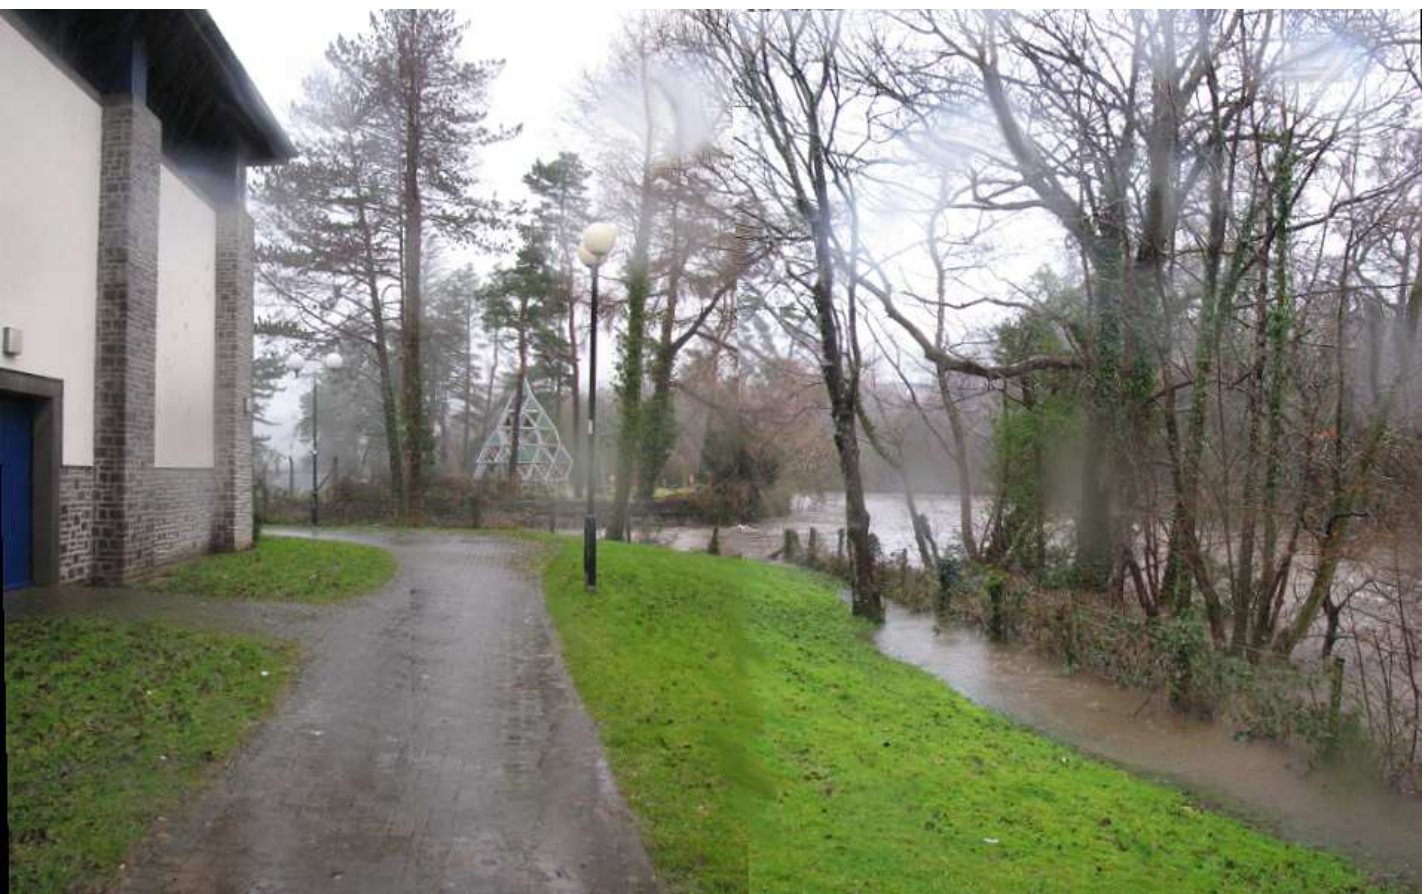
Figure 9: River encroachment at the Leisure Centre. This building is at risk of flooding from the river, and also through inland water routing from flooded land around the Fire Station.

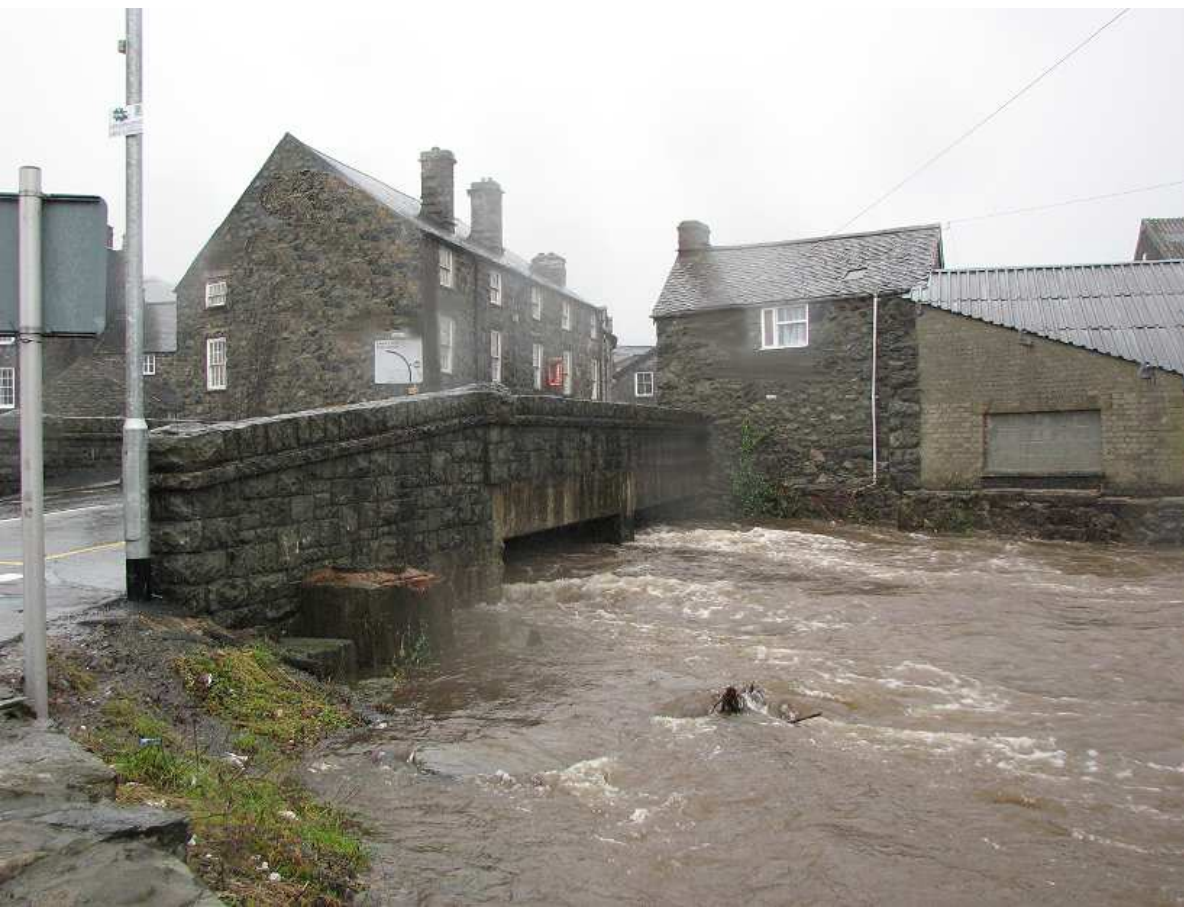
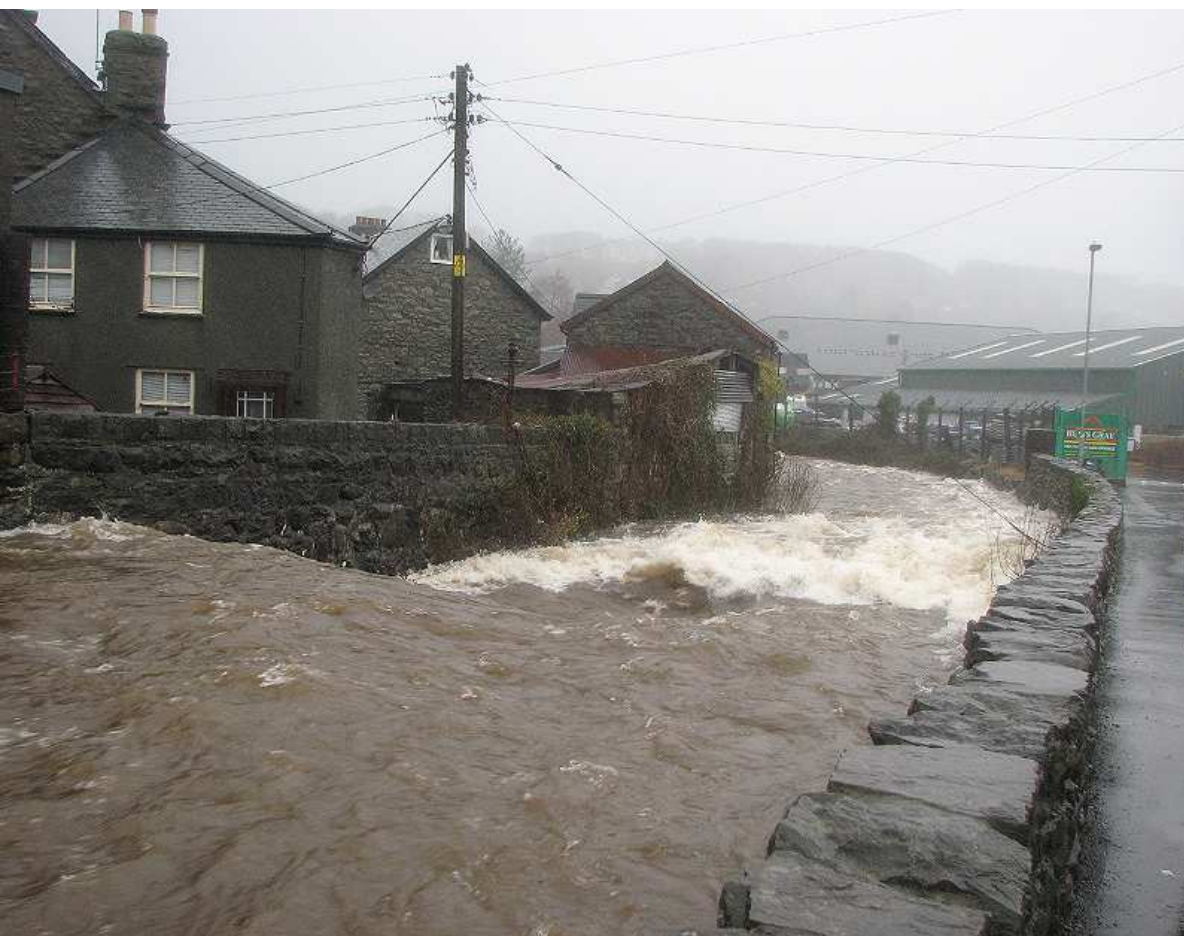
Figure 10: Arran Road bridge. Some flood risk exists because of the very low clearance below the bridge, which in turn is due to extensive gravel accumulation at this point. Downstream of the immediate bridge area, substantial high flood walls protect properties in the town.
