# Flooding in Dolgellau

## **Background**

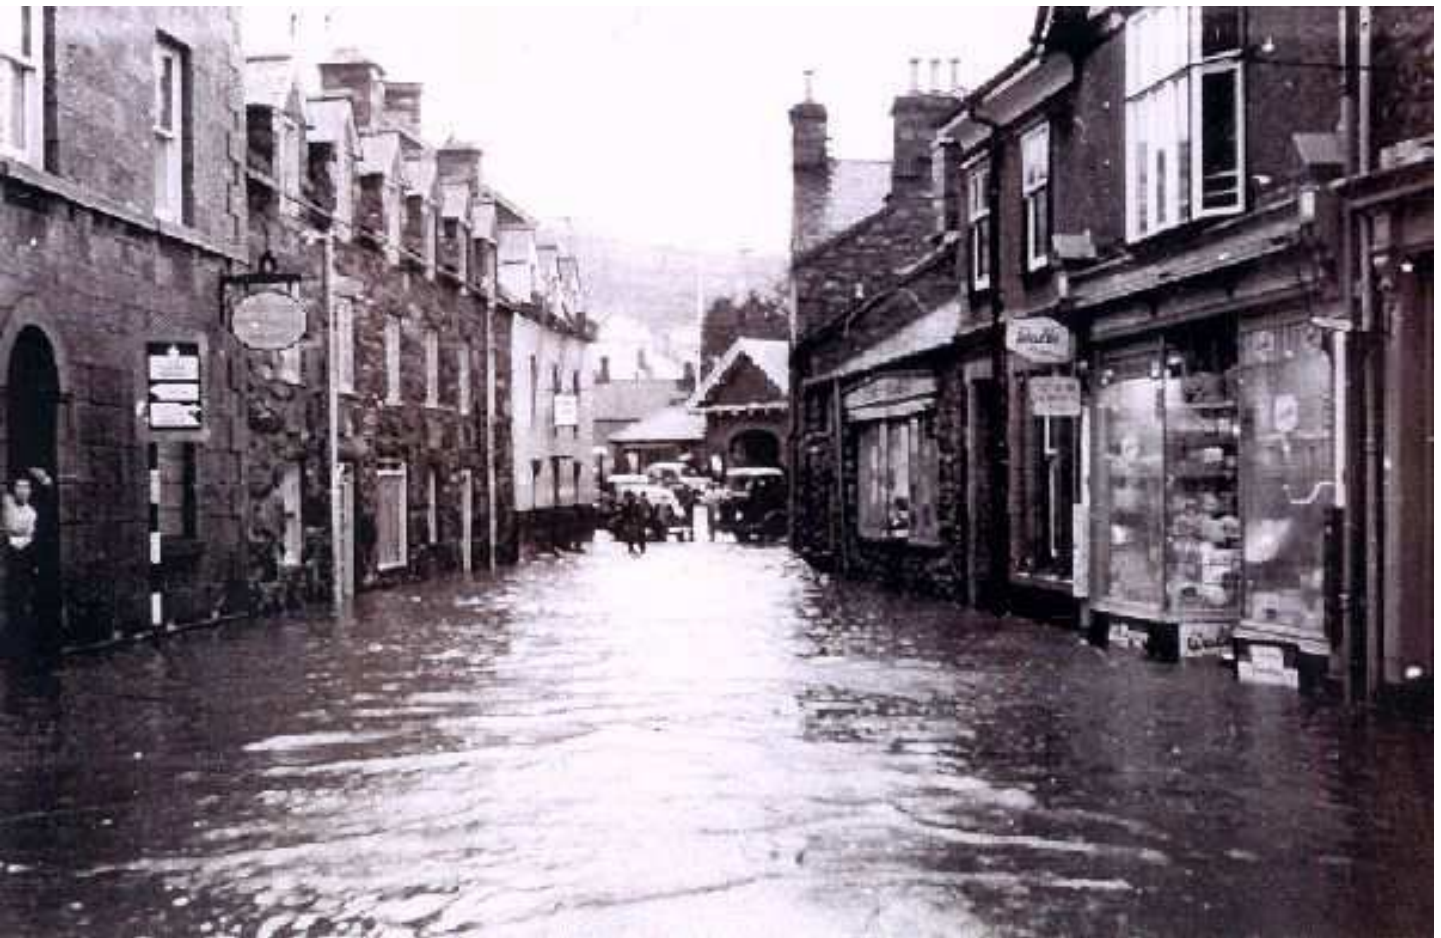
Flooding has historically been a cause for concern in Dolgellau. Following a serious flood in December 1964 when shops in Bridge street were inundated (illustrated above), a flood defence scheme was implemented by the local authority. The main feature of this scheme was the construction of masonry walls to a height of approximately 3m above river level along the stretch of river bank from the Arran confluence to the eastern end of the Marian Mawr fields. The scheme has been successful for over 40 years in preventing flooding of the town centre, but there is concern that the river wall at the Bont Fawr car park has come close to overtopping during recent major flood events. It is now considered necessary to re-examine flood defences for Dolgellau, and a proposal for a major new scheme by the Environment Agency has reached a consultation stage (Environment Agency, 2010).

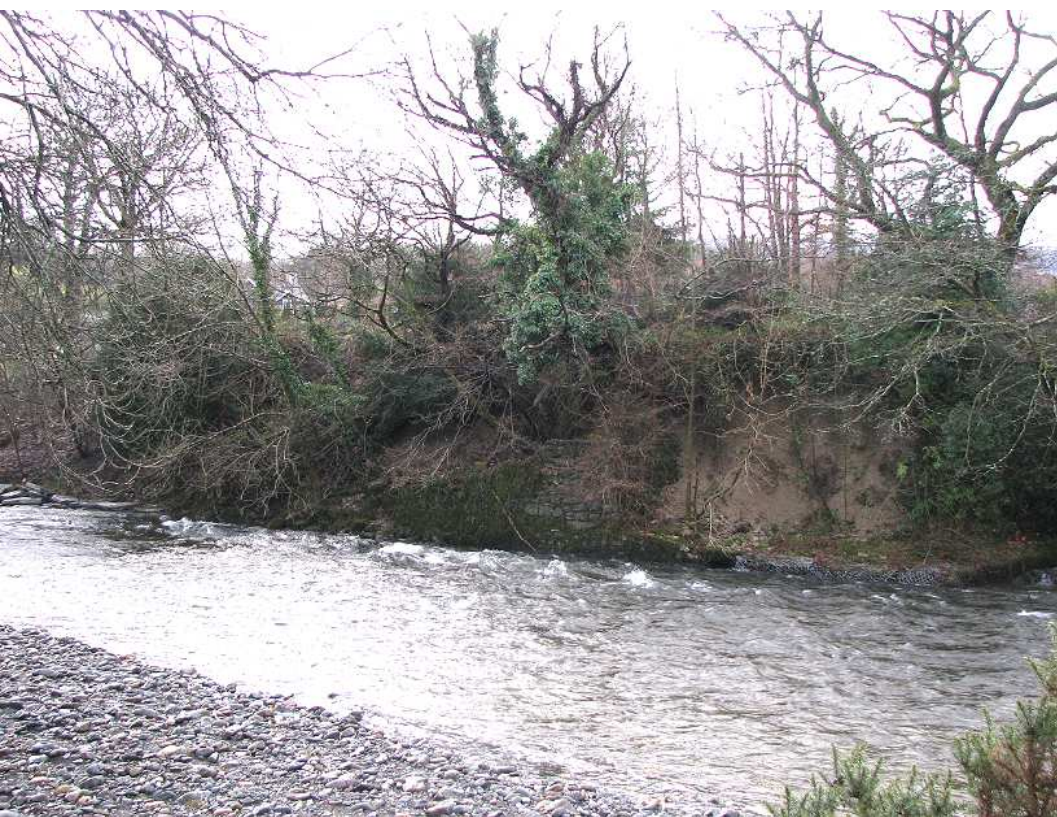
Figure 3:

Natural rivercliff in  
glacial/periglacial sands  
and gravels.

At the upstream boundary of the town on Arran Road, glacial/periglacial deposits produce a natural rivercliff approximately 3m in height.

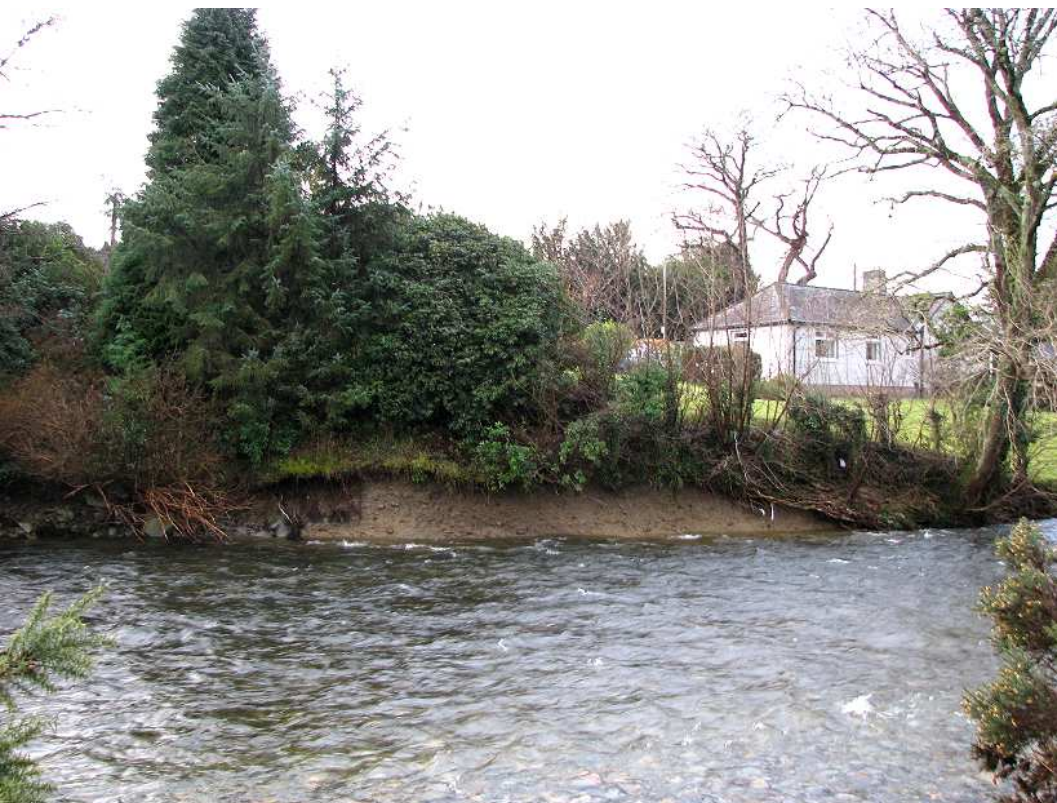
Figure 4:

Downstream limit of the  
rivercliff feature.

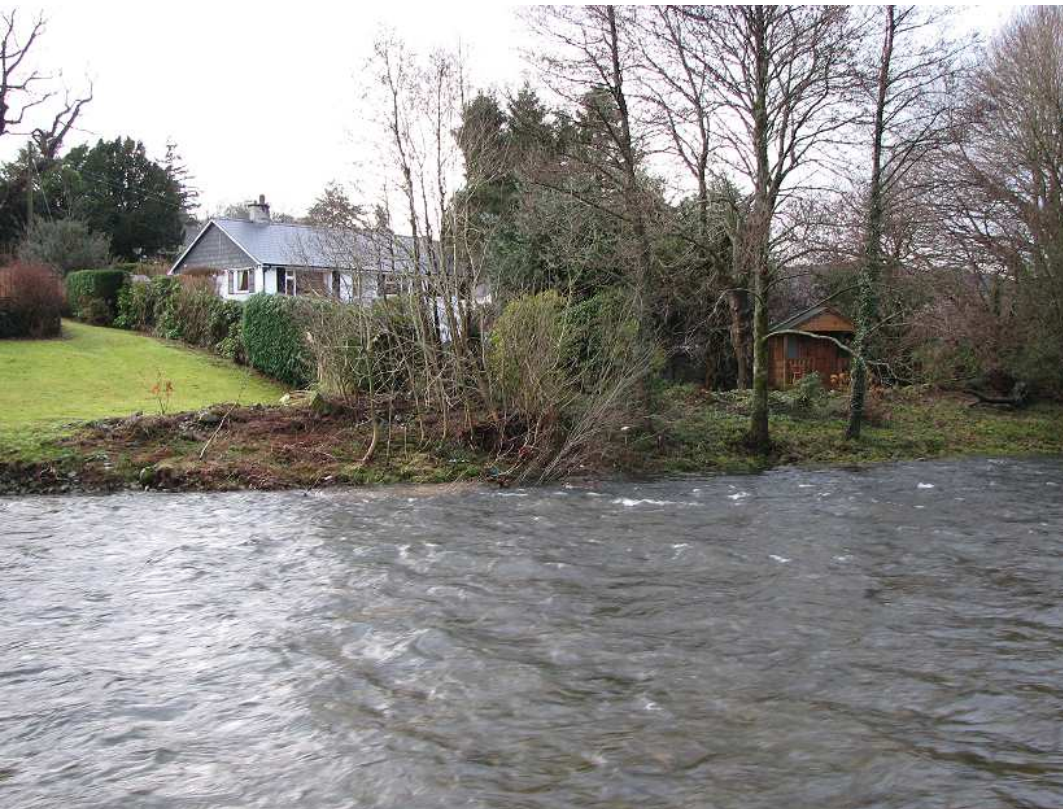
Figure 5:

Semi-natural riverbank of rocks and pebbles, overgrown with scrub woodland in places.

The banks are relatively low along the reach between the rivercliff and the confluence with the Arran stream. The banks are semi-natural, built up in places with large rocks, but no systematic construction of flood defences has been attempted. This section of bank is overgrown in places and appears to be unused.

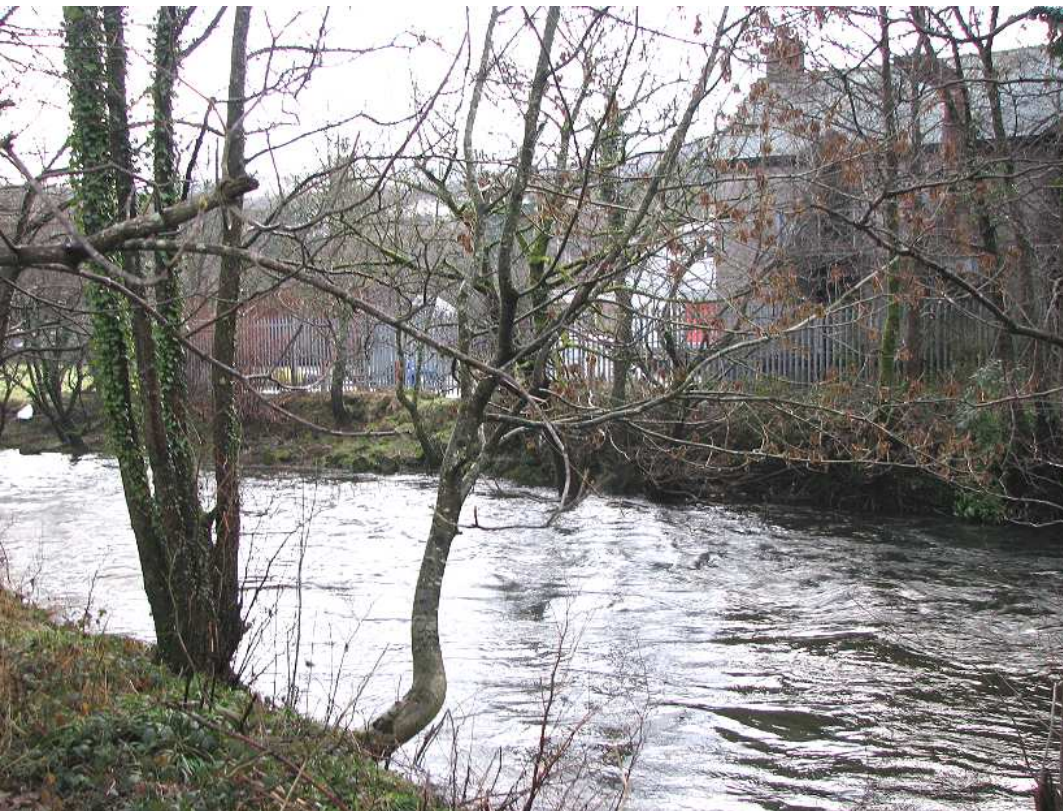
Figure 6:

Semi-natural riverbank of rocks and pebbles at the rear of the Fire Station. The bank is unused, and overgrown with scrub woodland.

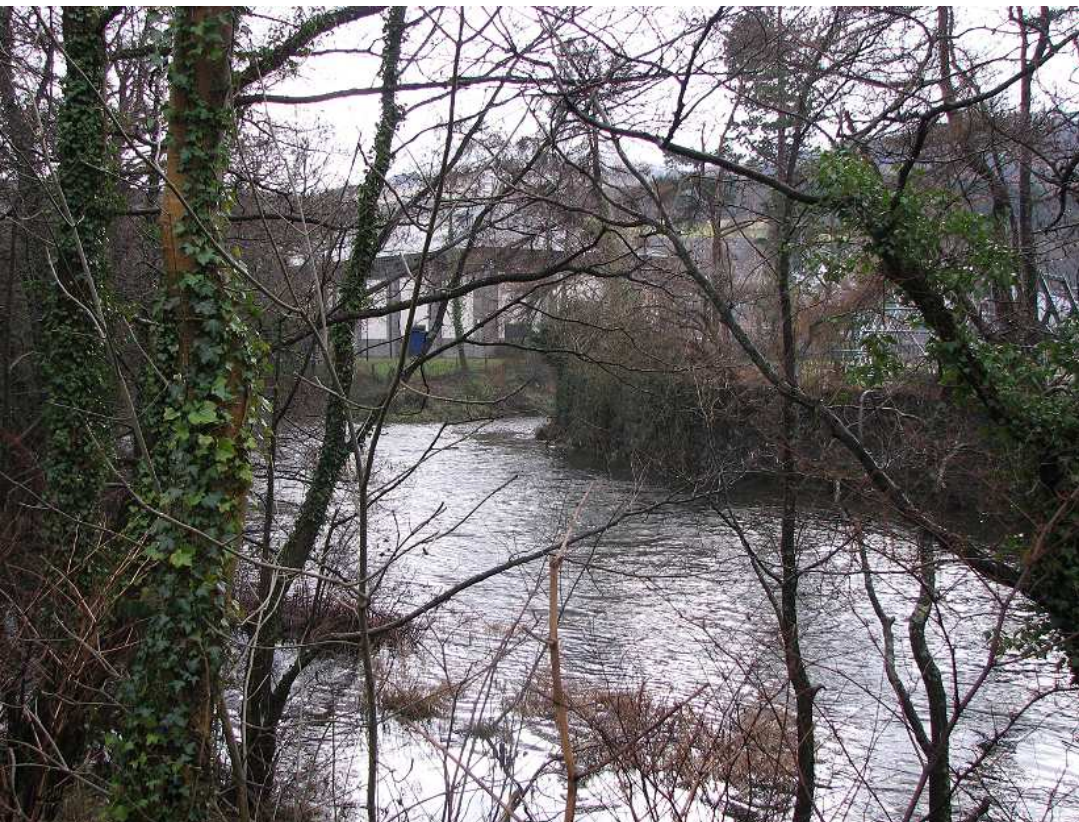
Figure 7:

Confluence of the Arran stream, with the leisure centre building beyond.

Downstream of the confluence are the substantial masonry walls of the 1960's flood defence scheme. The ground above, now occupied by the park, appears to have been built up at the time of the wall construction.

The section between the Arran confluence and the Bont Fawr car park is the location of the masonry flood defence walls constructed in the 1960's. These are in good condition, and extend to approximately 3.5m above river level.

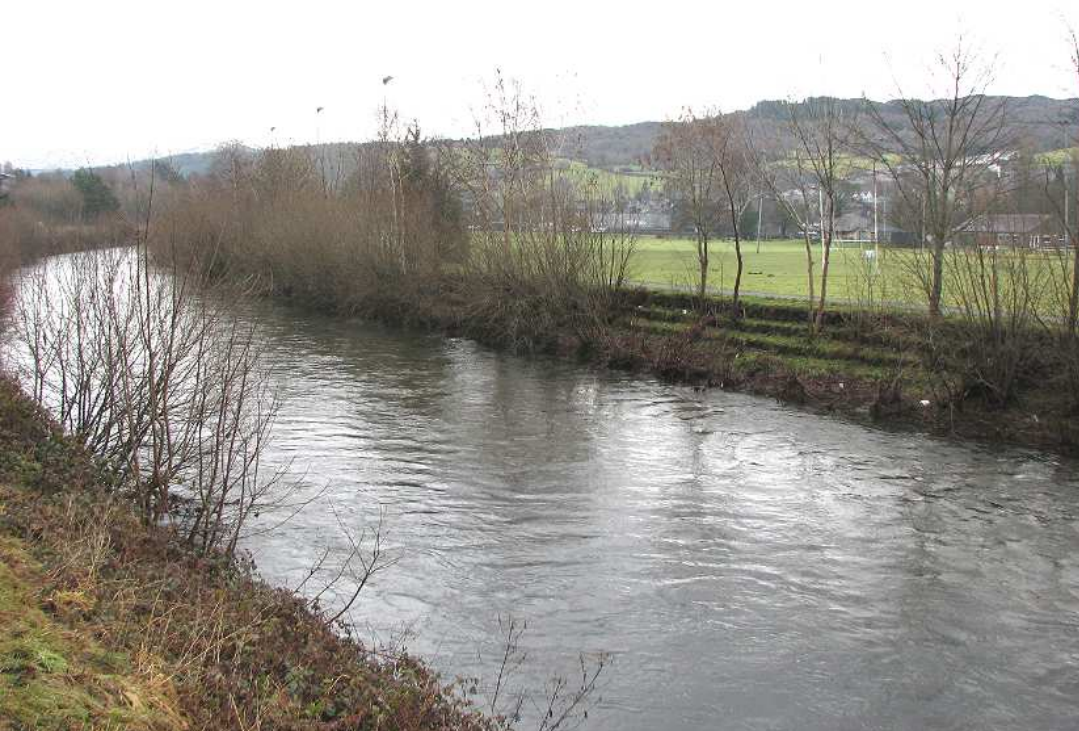
Figure 8:

Gabion walls alongside the Marian Mawr fields.

The walls extend to approximately 2m above the level of the fields. Their purpose may be to stabilise the river channel, realigned as part of the Dolgellau by-pass road scheme in the 1980's, rather than to provide flood defence.

Alongside the Marian Mawr fields, the river bank is constructed from rock-filled gabions, with large rocks forming the bank further to the west.

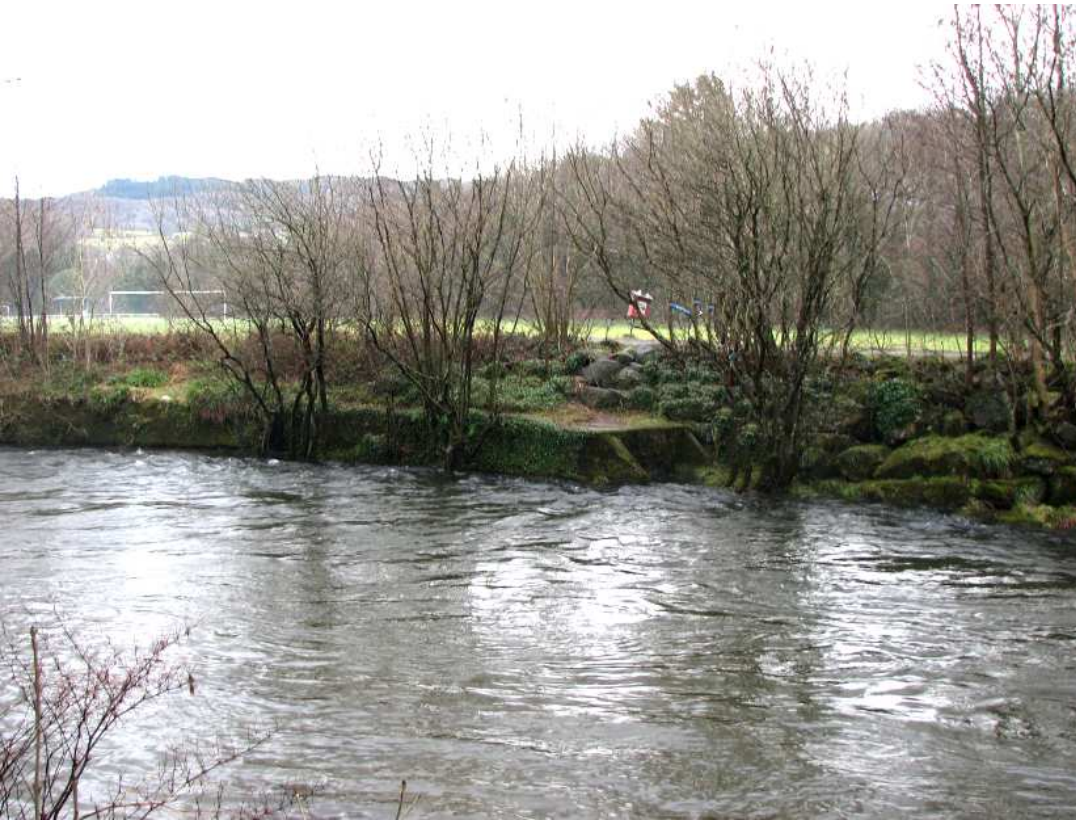
Figure 9:

Boulder walls alongside the Marian Mawr fields.

The banks alongside the downstream section of Marian Mawr are constructed of large loose boulders, piled in places onto a concrete footing. It is uncertain whether water is able to flow through this construction at high river levels.

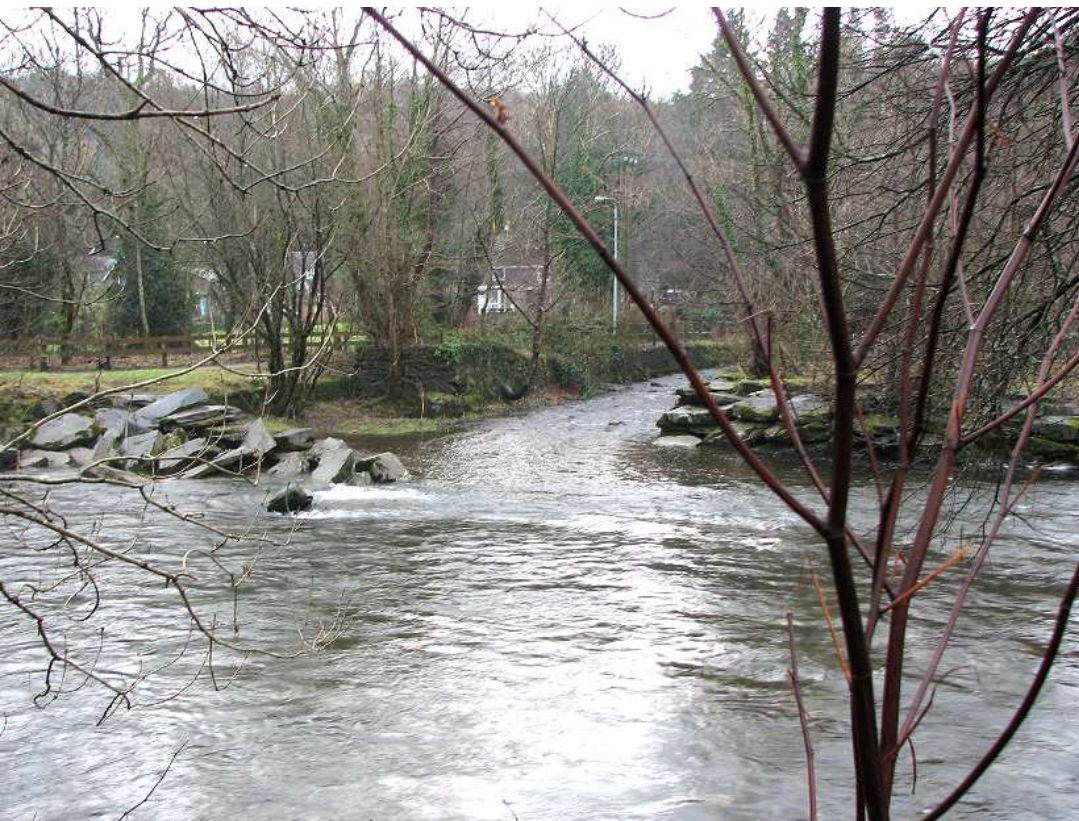
Figure 10:

Confluence at Pandy'r Odyn.

Large loose boulders reinforce the river bank and have been placed to deflect the main channel flow at the confluence.

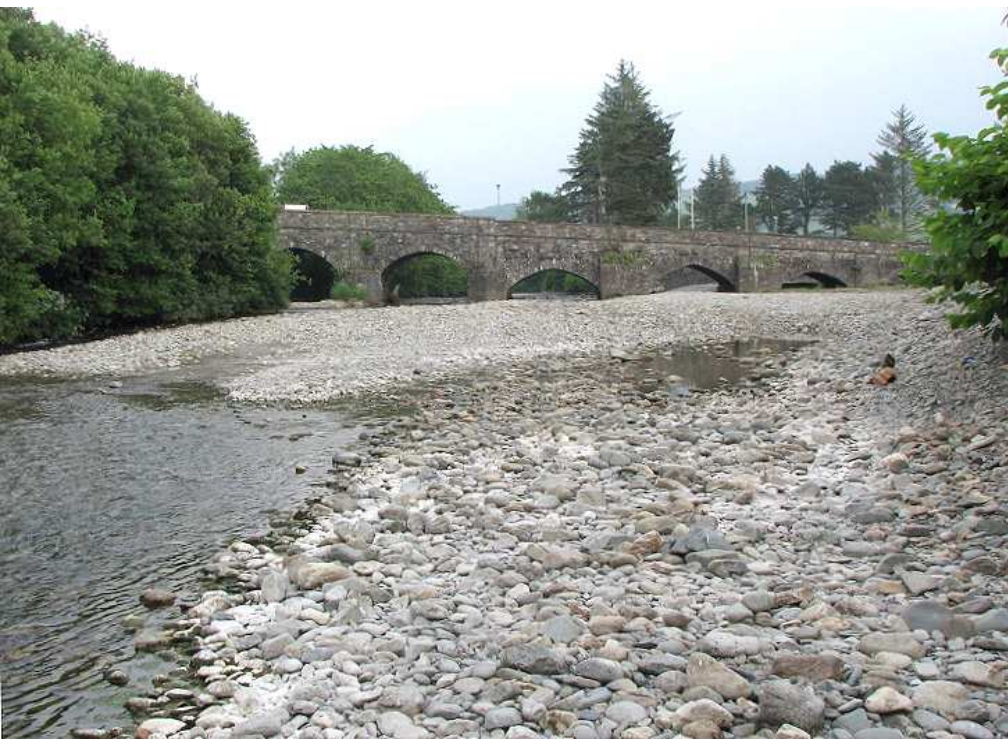
Figure 11:

Recent sediment accumulation downstream from Bont Fawr

Gravel deposition is greatest in the sections of the Afon Wnion with lowest gradient, notably on the eastern outskirts of the town at Arran Road, and along the reach between Bont Fawr and the western end of the Marian Mawr fields (figs 11 and 12).

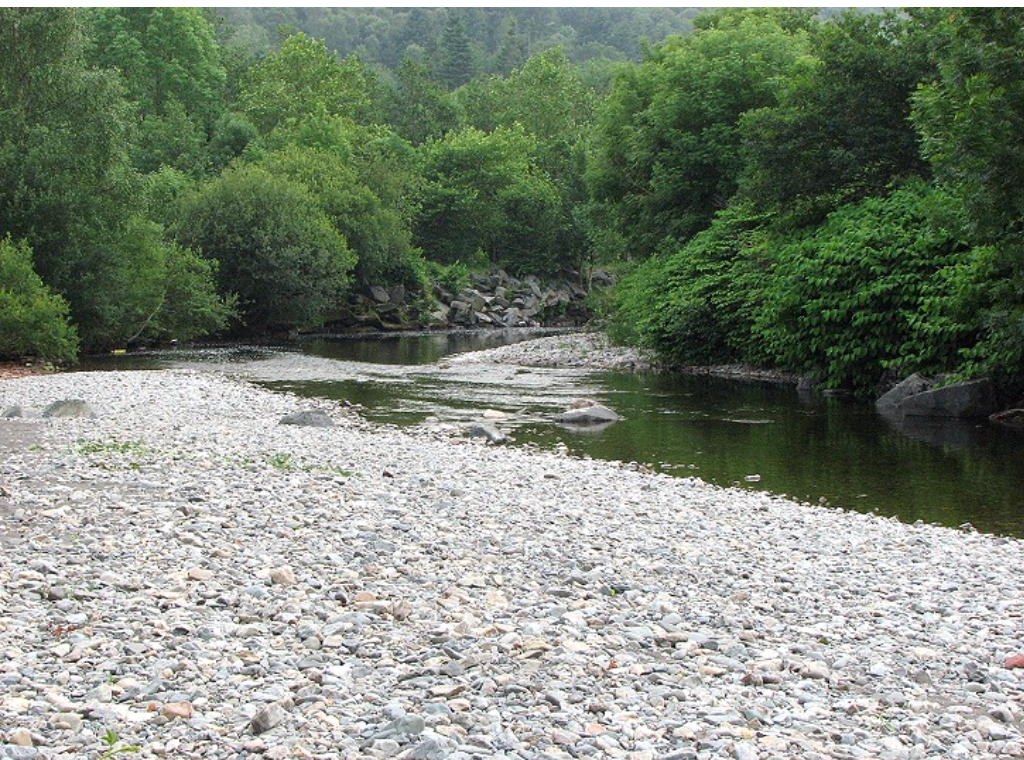
Figure 12:

Sediment accumulation alongside the Marian Mawr fields

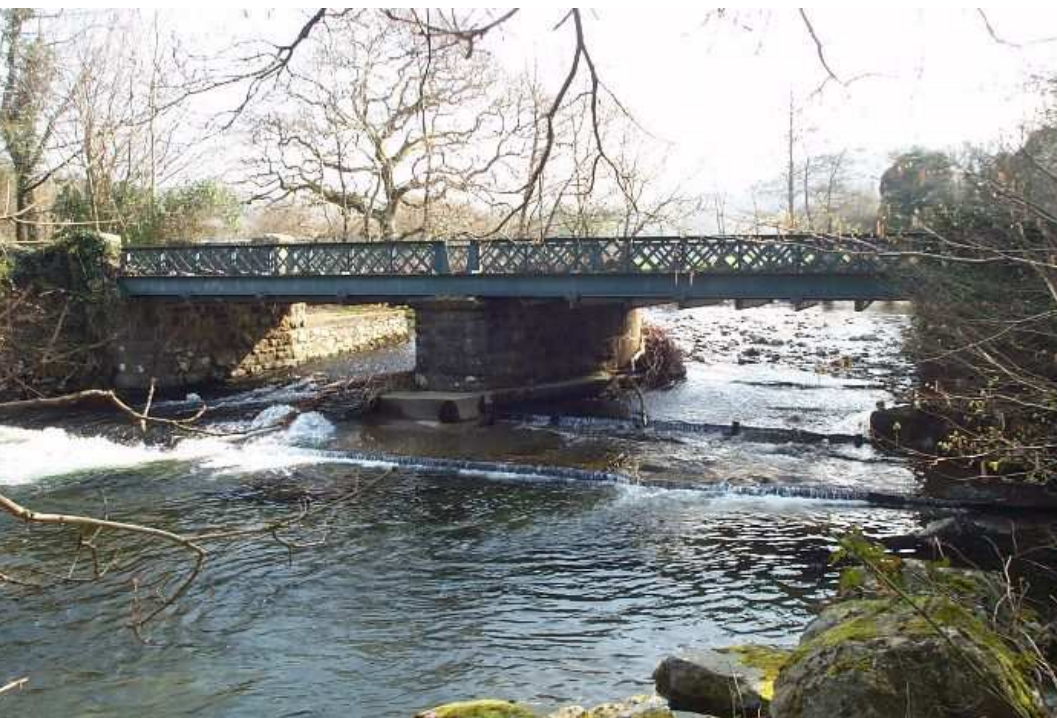
Figure 16:

Weir at  
Dolserau Bridge

Weirs should be of stone or concrete construction at a shallow angle, similar to that at Dolserau Bridge (fig. 13), to reduce any obstruction to fish migration.

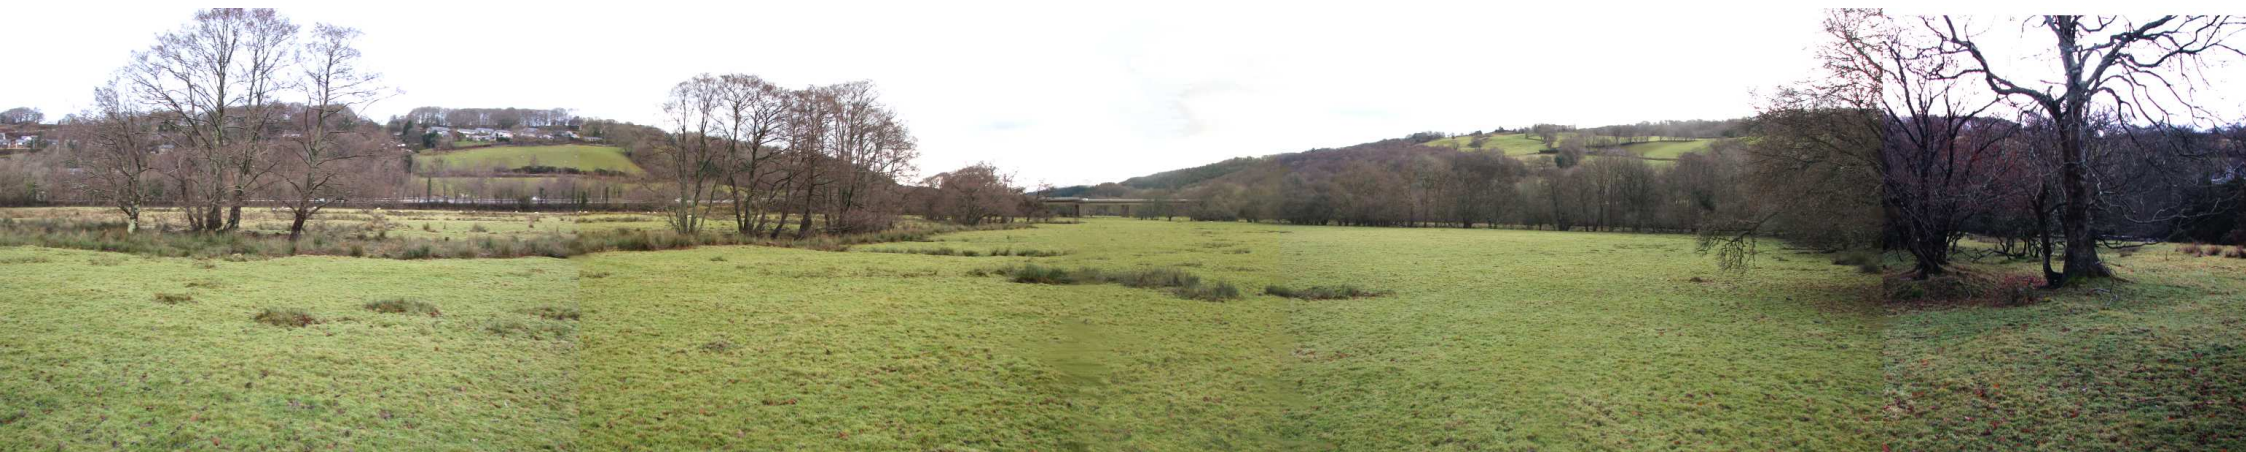
Figure 17: Proposed flood interception basin east of Dolgellau

During flood conditions, low lying fields to the east of Dolgellau are susceptible to flooding. The value of this land in reducing peak flood discharge can be enhanced by introduction of a side-weir in the river bank to direct flood waters into the basin under flood conditions. The outlet from the basin may use controlled drainage through pipes to allow emptying over the 24 hour period following the flood peak. This should not interfere unduly with normal agricultural activities on the land. Similar strategies have been adopted by the Environment Agency in Northern England (personal communication) as an effective addition to hard engineering solutions.
