Coastal erosion at Friog and its consequences

Graham Hall, PhD FGS

October 2023

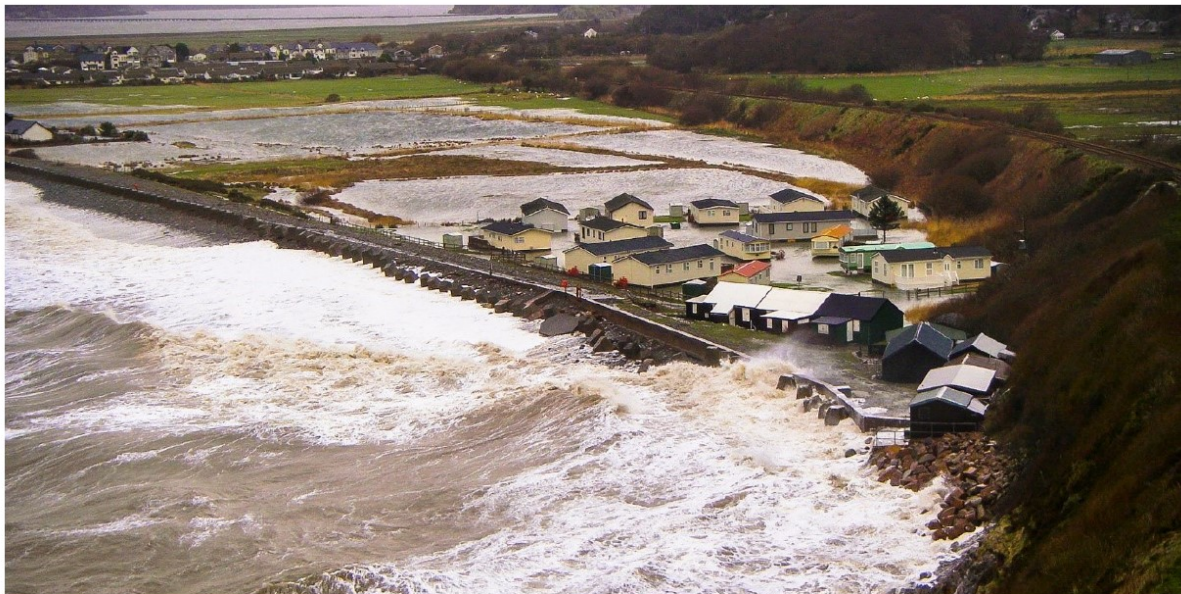
Figure 1: Failure of the eroded section of the Ro Wen shingle spit at Friog corner during a storm, causing localised flooding.

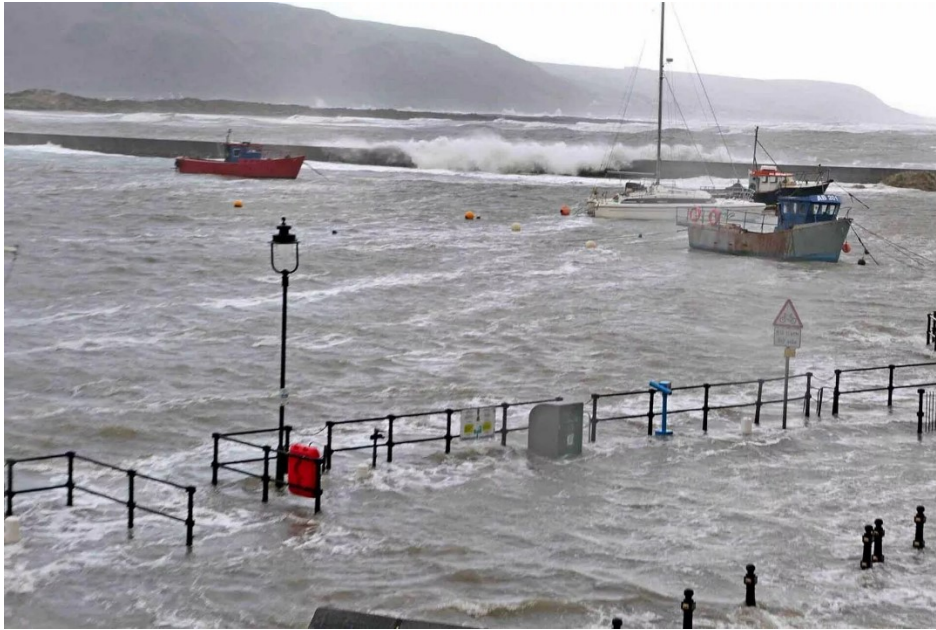
Figure 2:

Flooding in Barmouth. Fairbourne, in the middle distance, is well protected by the Ro Wen shingle spit which has not been overtopped.

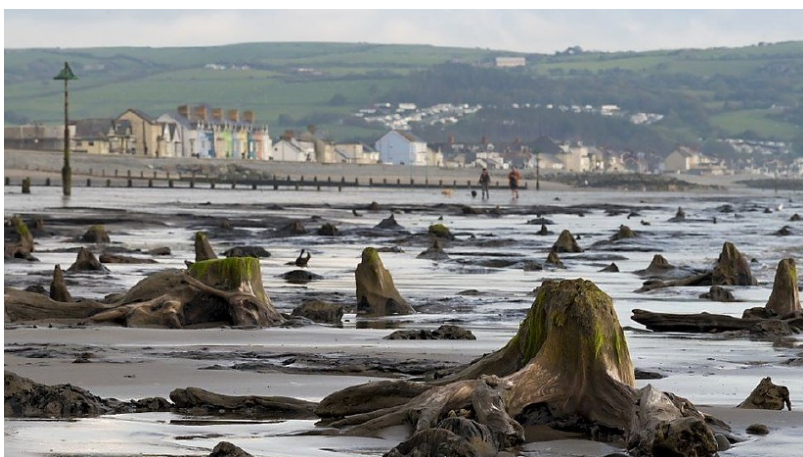
Figure 3:

Remains of the submerged forest at Borth, exposed during exceptionally low tides.

Further sand and gravel was washed out from the melting ice sheets at the end of the glacial period, with finer material deposited in the shallow waters of Cardigan Bay to form a coastal plain. A relic of the former coastal plain can be seen at very low tides in Borth, where remnants of a former forest are exposed (fig.3).

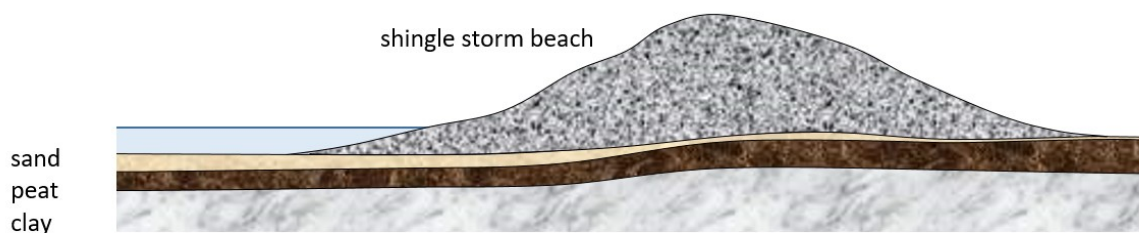
The source of shingle for the Ro Wen spit is the offshore terminal moraine, along with shingle transported by wave action from the low cliffs of glacial moraine at Llwyngwrl. The spit was deposited on a base of estuary clay, lagoonal peat, and marine sand and gravel.

Figure 5: Structure of the Ro Wen shingle spit.

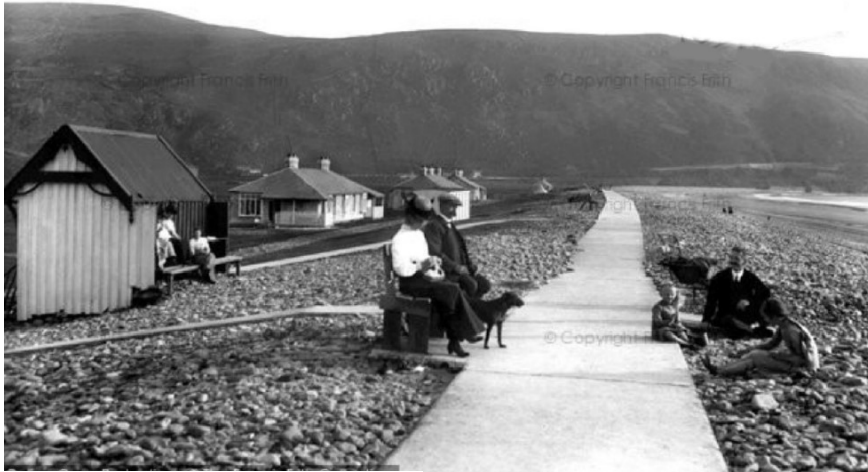
Figure 6:

One of the works undertaken by Solomon Andrews was to excavate the crest of the shingle storm beach and emplace a concrete defence wall. This wall ran from the north of Fairbourne village to the cliffs at Friog, and was intended to stabilise the shingle spit before houses were constructed below the inland slope of the shingle embankment (fig.6).

Photograph from about 1915 showing the sea wall constructed by Solomon Andrews to protect the newly established seaside resort of Fairbourne.

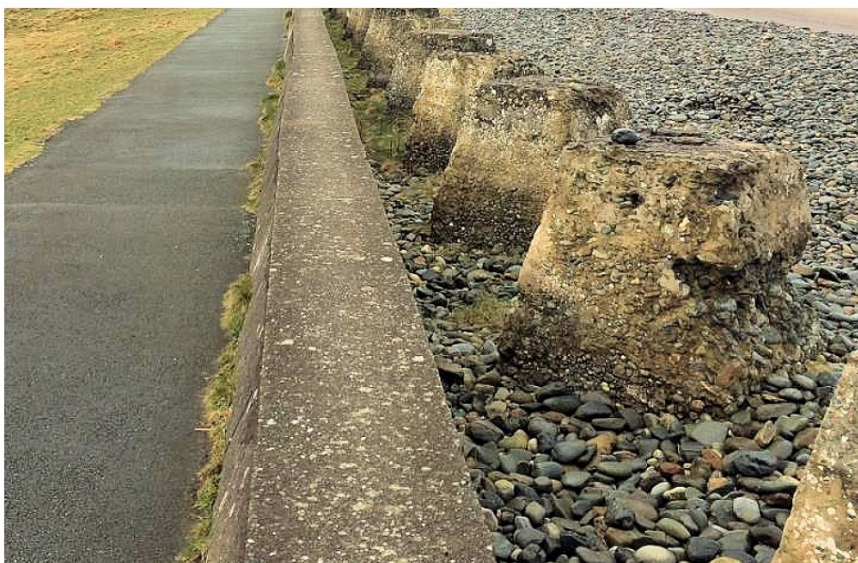
Figure 8:

Around 1975, problems occurred with wave overtopping during storms, and a side wall was added to raise the height of the storm beach crest (fig.8). The wall has had the beneficial effect of causing further shingle to accumulate on the top of the storm beach, where it is thrown by storm waves.

Present day elevated crest wall constructed alongside the original sea wall to provide extra protection. Notice the accumulation of shingle against this structure.

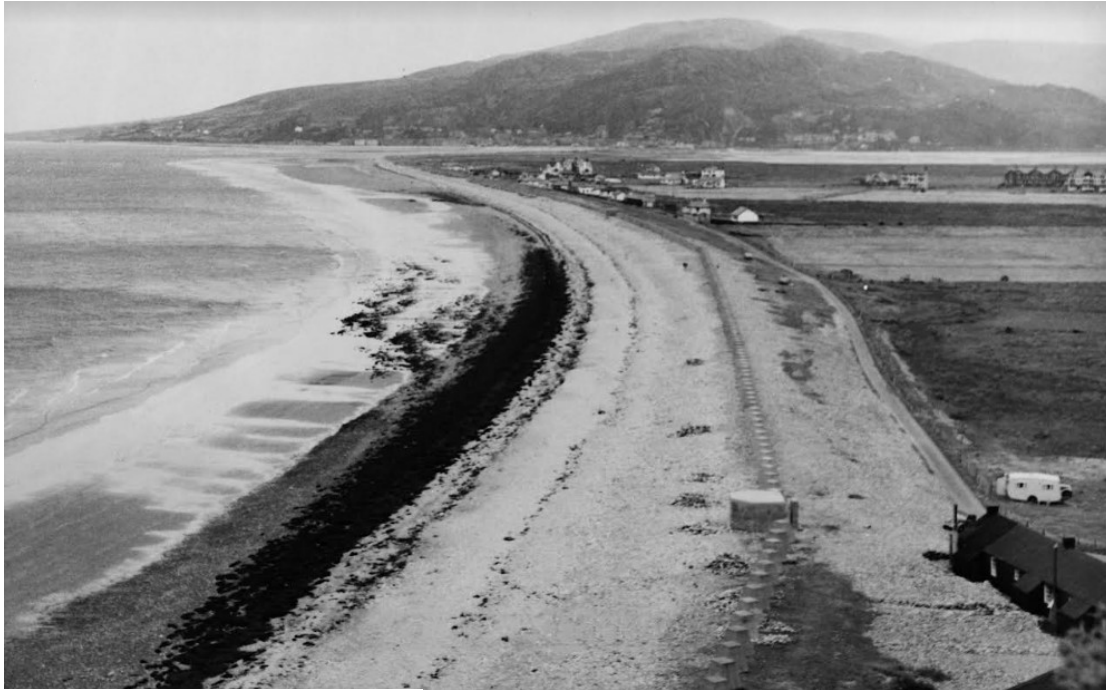
A photograph taken in 1955 at Friog corner (fig.9) shows no evidence of coastal erosion. There is a wide expanse of storm beach shingle on both the seaward and landward sides of the crest line, which is marked by World War 2 anti-tank defences.

Figure 9: Photograph of the Ro Wen shingle spit taken in 1955. In the foreground is the row of huts at Friog corner, and the early development of the Friog Farm caravan park.

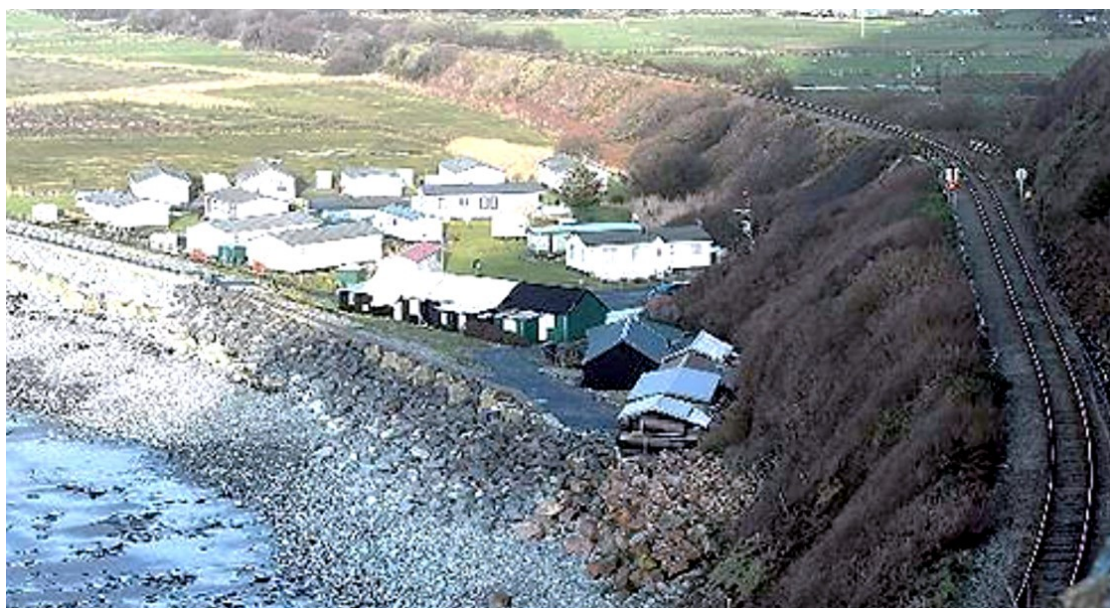
In the 1990s there was a breach of the embankment by the huts at the end of the sea wall. This was repaired by Natural Resources Wales and Railtrack, and the repairs appear at the time to have been very satisfactory (fig.10).

Figure 10: Repairs to the coastal defences at Friog corner, carried out in the 1990's. These works included the placement of rock armour along the line of the sea wall.

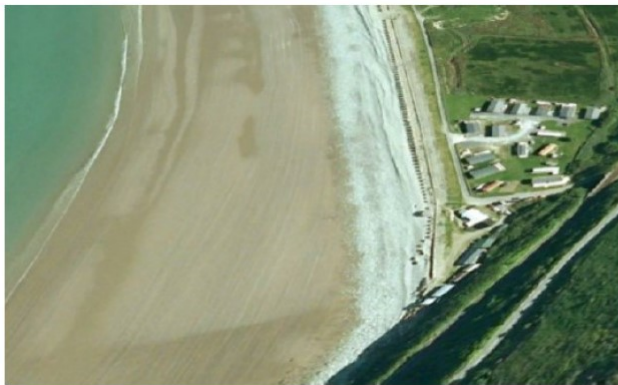
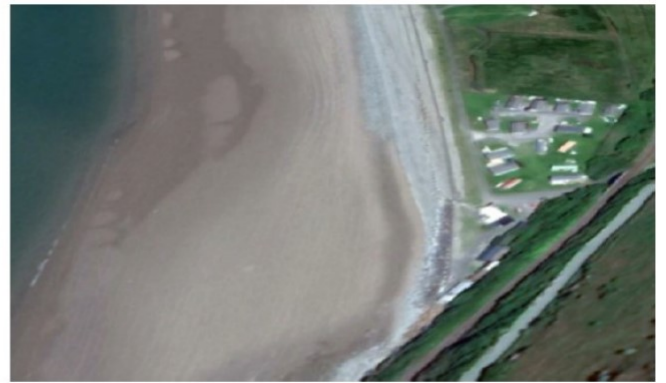
However, coastal erosion has continued at Friog corner, as seen from air photographs (fig.11).

Figure 11: Comparison of the extent of storm beach deposits at Friog corner (Google Earth).

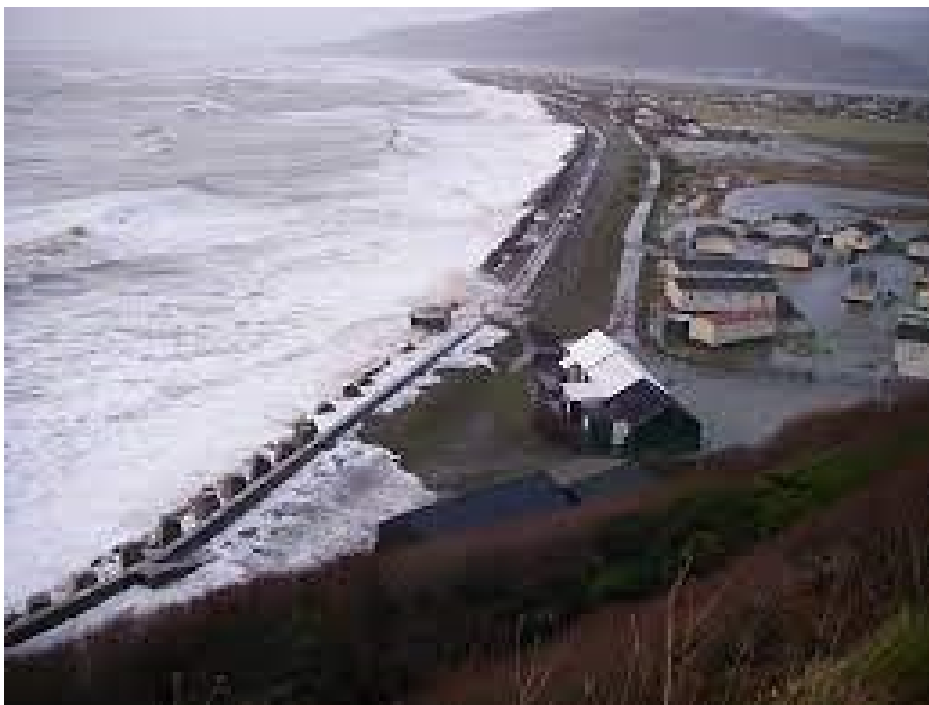
Failure of the sea defences finally occurred at Friog corner during a storm in 2014. The Friog Farm caravan park was flooded to a shallow depth, along with neighbouring agricultural land, although Fairbourne village was unaffected (fig.12).

Figure 12: Flooding at Friog corner during a storm in 2014.

From the above photograph, it is possible to suggest the cause of the flooding:

There is little evidence of wave overtopping on a scale which could produce the volume of flood water seen.

In the foreground, water from breaking waves appears to be flowing horizontally *between* the cap wall and the core wall of the spit. Again, however, this would only occur for a relatively short period at high tide and would be unlikely to provide the volume of flood water observed at the caravan park and adjacent fields.

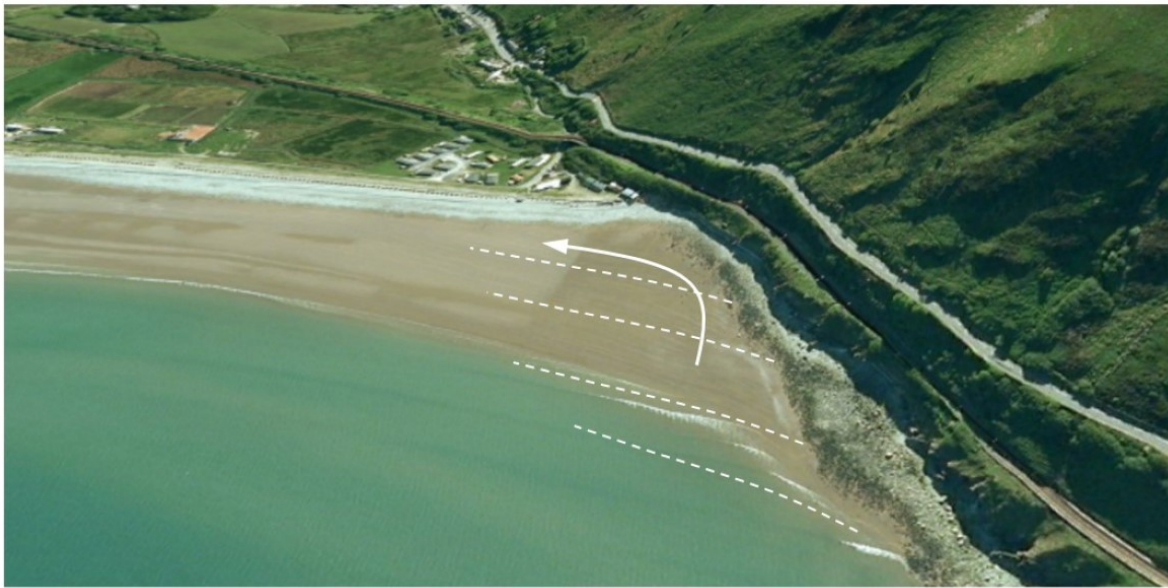
Examination of wave action at Friog indicates that waves are refracted around the headland and approach directly towards the shore (fig.15). The geometry of the bay causes a strong water flow

northwards parallel to the shore at this point. The powerful current is able to pick up and transport the finer shingle from the shoreface, leaving only the coarser cobbles in place.

Figure 15: Approach of waves at Friog corner, and redirection of the water mass along the spit.

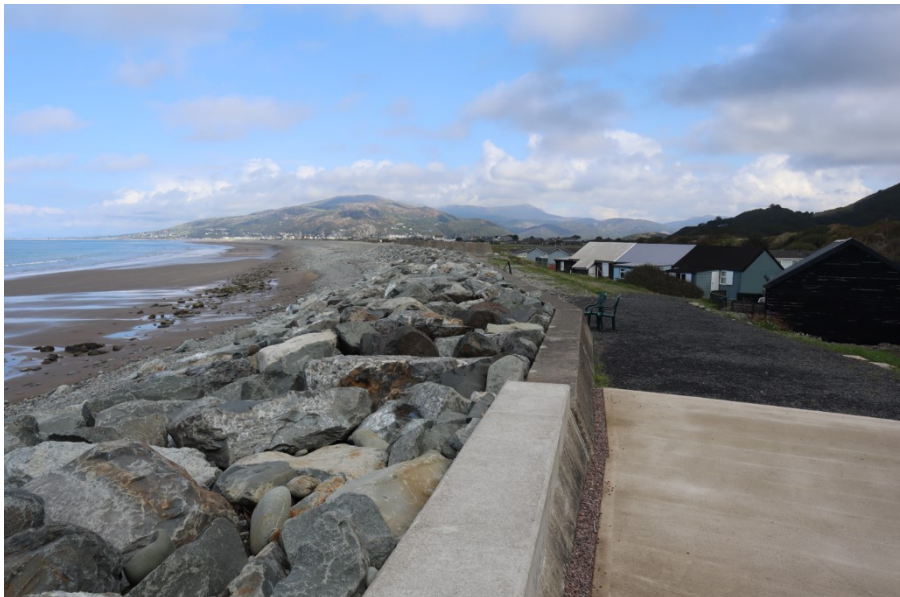
The first phase of the work involved replacement of the old sea wall with a more substantial concrete structure. This was then protected with rock armour placed at a surface angle of a little over 20° (fig.17).

Figure 17: Replacement section of concrete sea wall in the foreground, with rock armour.

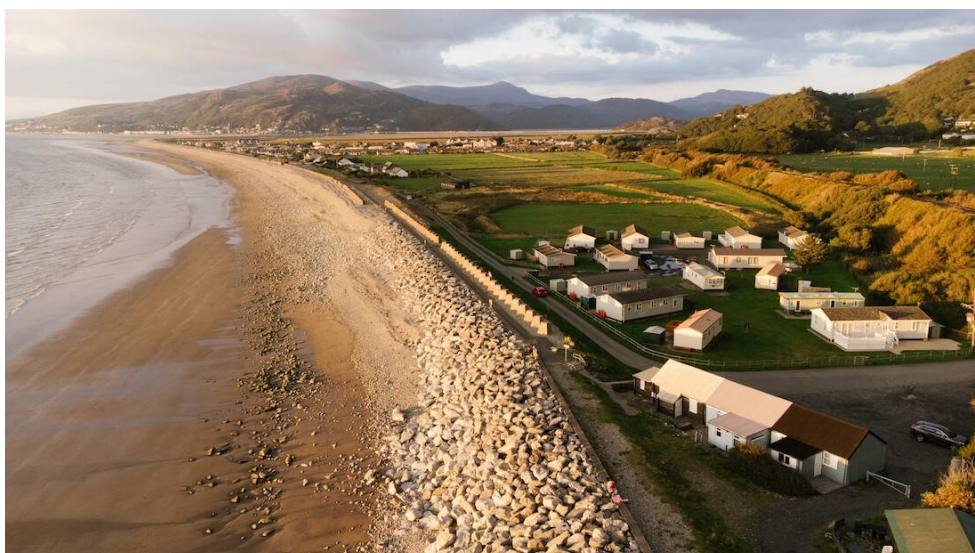
Figure 18:

A second phase involved the emplacement of similar rock armour from Friog corner to the northern boundary of the caravan park (fig.18).

Extension of the rock armour in front of the caravan park.

The replaced section of concrete sea wall is in front of the huts in the foreground.

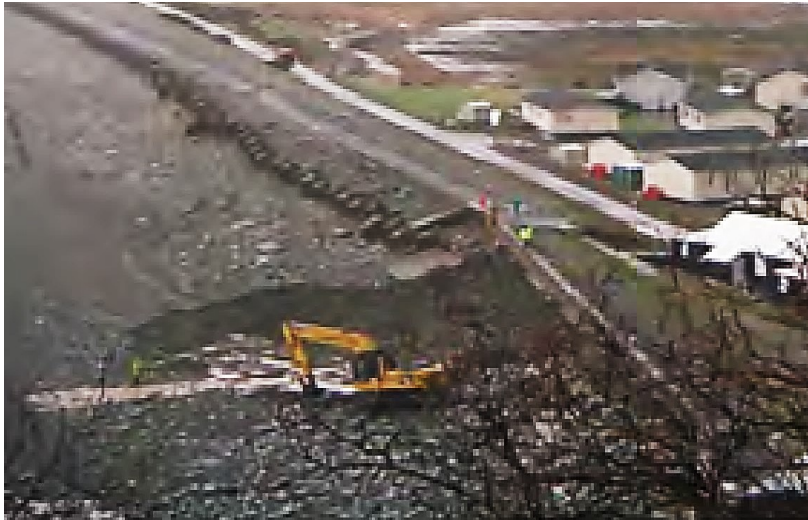
Figure 19:

In order to carry out this work, existing storm beach deposits were excavated to produce a shortened 20° seawards slope. The excavated material is seen to be shingle along with grit and sand washed into the cavities between pebbles as seawater enters the shingle bank at high tide (fig.19).

Work in progress to prepare the seawards slope of the shingle spit for emplacement of rock armour.

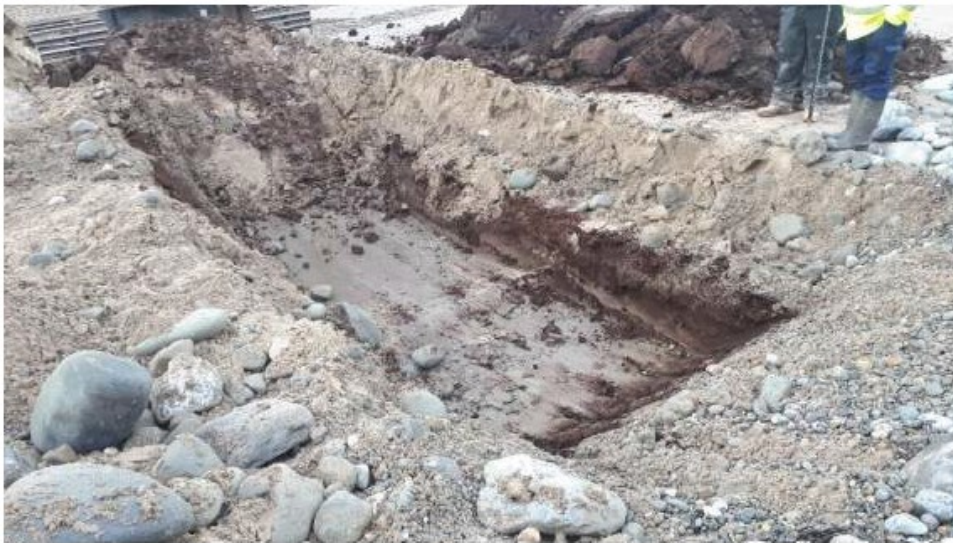
Figure 20:

It was considered necessary to excavate into the underlying peat and clay to provide a stable foundation for the toe of the rock armour slope (fig.20).

Peat layer visible above clay in an excavation to stabilise the toe of the rock armour slope.

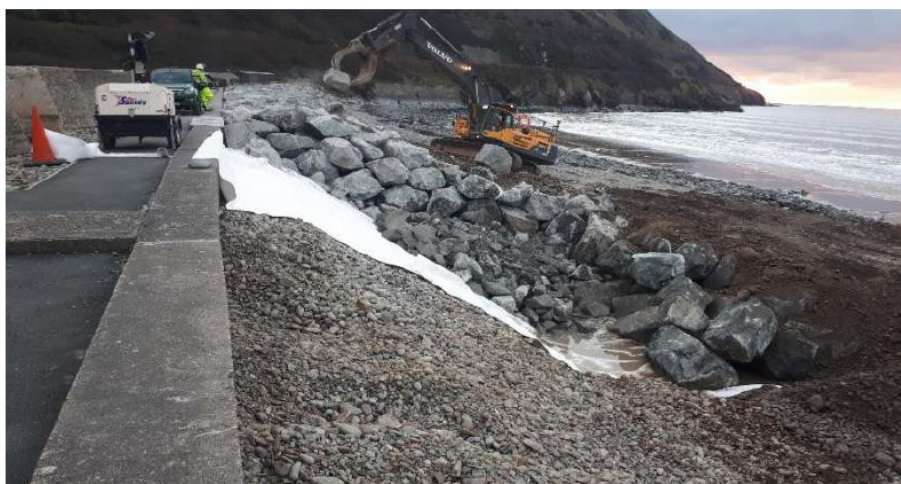
Figure 21:

After placement of a geotextile sheet, rock armour was placed on the prepared slope (fig.21).

Work in progress to place the rock armour on the prepared seaward slope of the shingle spit.

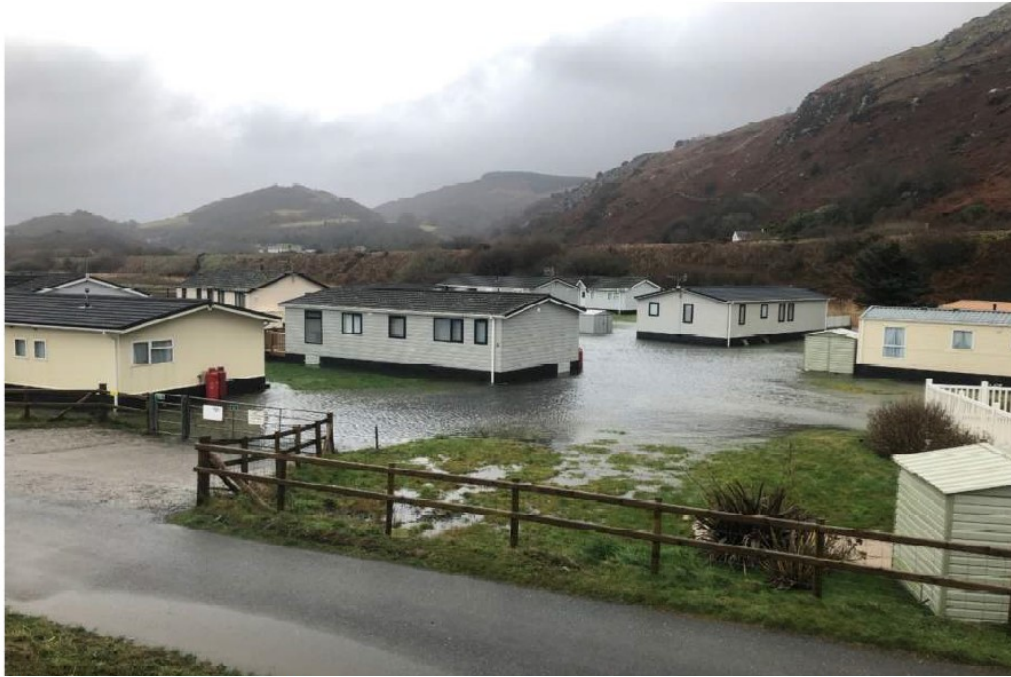
In February 2019, significant flooding occurred at the Friog Farm caravan park. This was at the time of a particularly high tide, but under normal sea conditions with no wave overtopping of the shingle storm beach. It was evident that water was flowing beneath the sea wall and emerging as a spring below the road (fig.22).

Figure 22: Flooding of the caravan park in February 2019. Water can be seen emerging onto the grass area to the right of the entrance gateway.

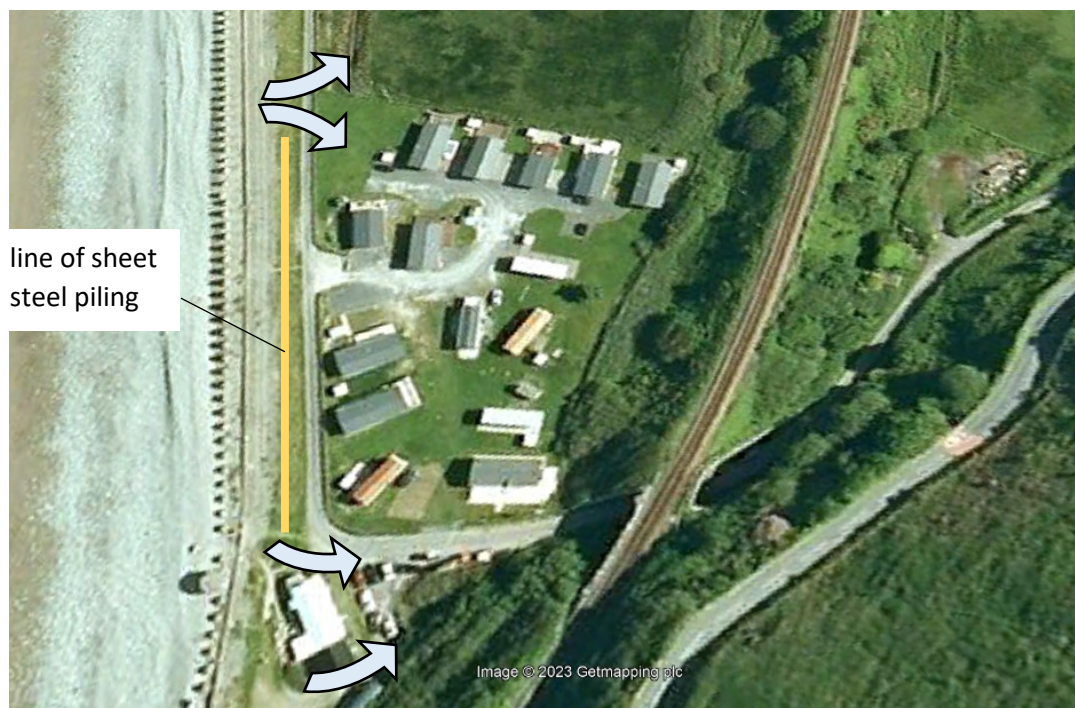
To remedy the flooding problem at the caravan park, sheet steel piling was installed along the length of the caravan park on the landward slope of the shingle embankment (fig.25), approximately 1.5 metres up from the road and extending downwards into the peat layer. The piles were emplaced to a depth of approximately 4m below the level of the road.

This intervention has been partially successful. The severity of tidal flooding has been reduced. However, water appears to build up behind the piling at high tide and is deflected to either the northern or southern end of the line of piling, where it again emerges as springs which threaten the caravan park.

Figure 25: Location of the line of sheet steel piling, and observed water flows at the northern and southern ends.

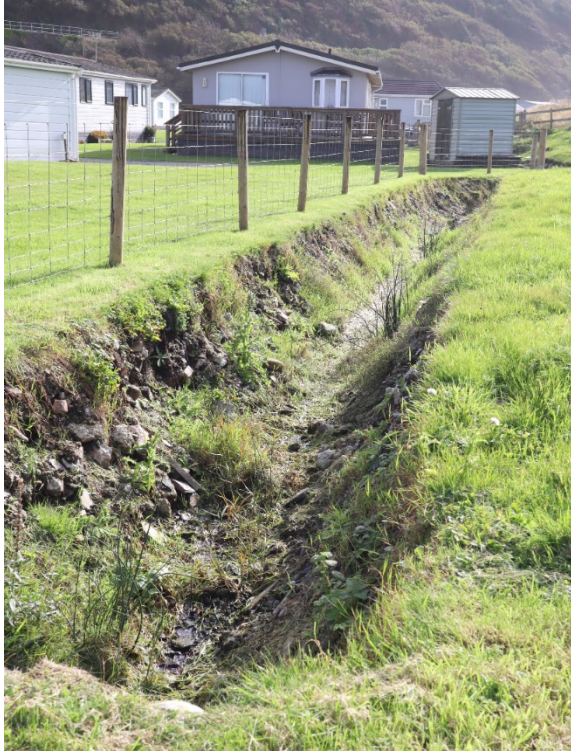
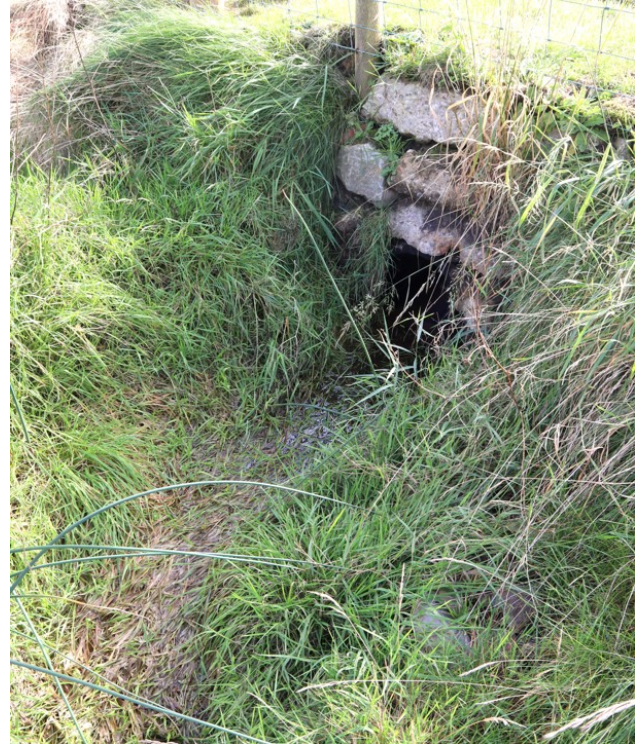
At the northern end, water discharges into a drainage ditch which has been dug to receive it. At times of exceptionally high tide, the flow can be significant (fig.26).

Figure 26: (left) drainage ditch constructed in front of the caravan park to intercept groundwater flow through the shingle spit at high tide. (right) culvert discharging into the Friog drainage ditch network.

The problem of water resurgence at the northern end of the site has been partially resolved. The recently constructed drainage ditch collects groundwater, which is discharged into the Friog drainage ditch network. This then flows via the Afon Henddol to the Mawddach estuary. It is recommended that the line of sheet steel piling be extended northwards by about 20m to reduce the amount of groundwater flow into the caravan park, and redirect water directly into the Friog drainage ditch network outside the site.

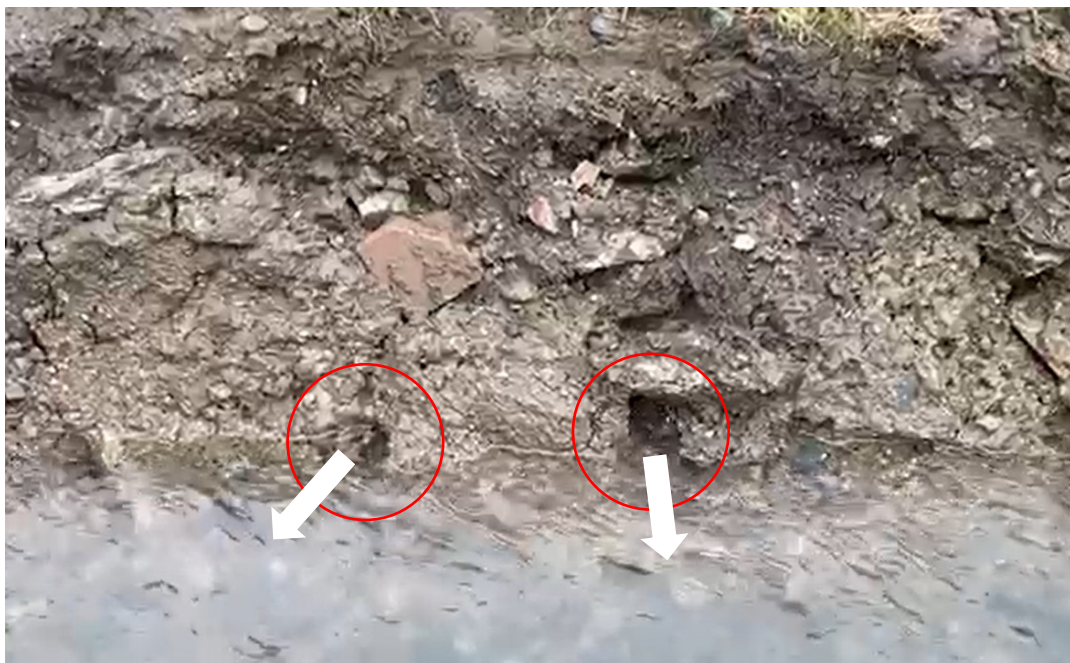
Groundwater can be seen to flow out of soil pipes under significant hydraulic pressure, as at the points marked in fig.27.

Figure 27: Groundwater seen to be flowing out of soil pipes (ringed in red) into the drainage ditch at the northern end of the caravan park..

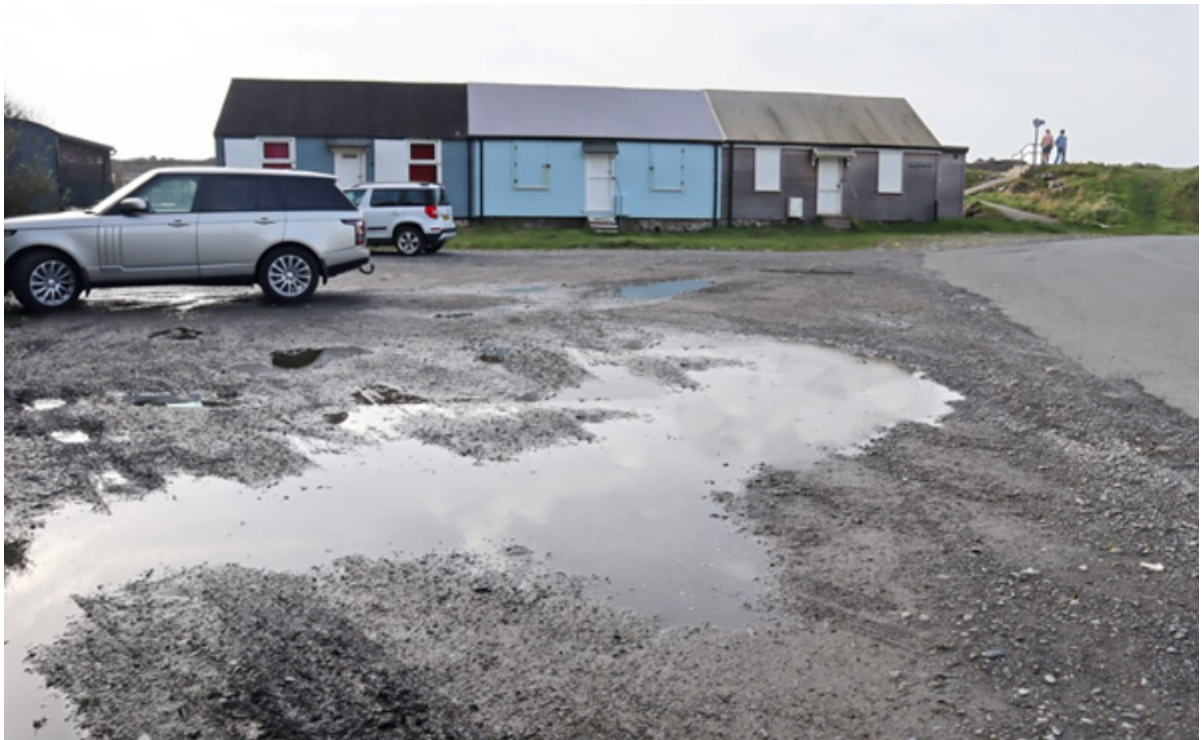
The southern end of the line of piles stops just before a line of huts. Water appears to discharge around and below the huts, causing regular flooding of the adjacent parking area (figs.28 and 29).

Figure 28: typical extent of water discharge onto the parking area by the huts at Friog at high tide.

Flooding of the parking area becomes severe on occasions, and can overflow into the caravan park. The photographs were taken on days with no recorded rainfall, so cannot simply be the result of rainwater runoff.

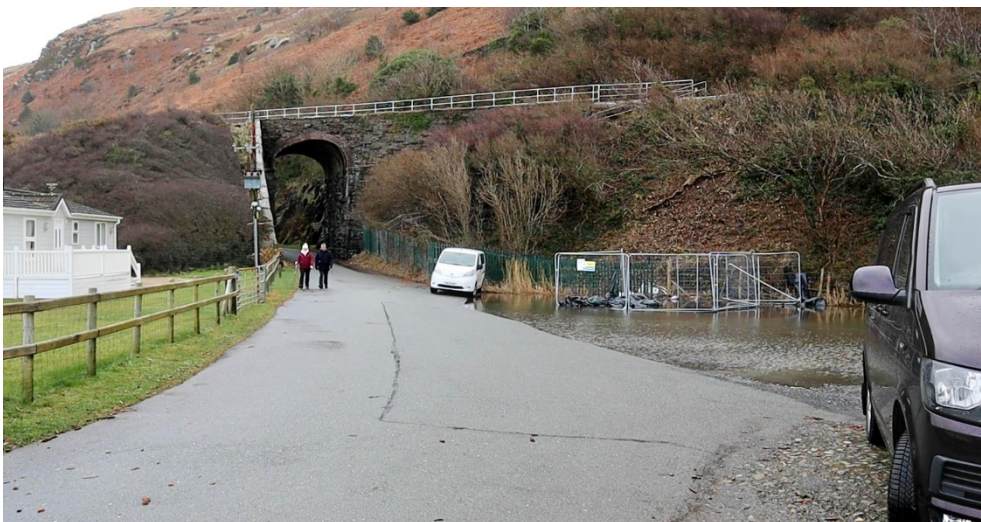
Figure 29:

More extensive flooding of the parking area at a high spring tide, with a risk of water entering the caravan park.

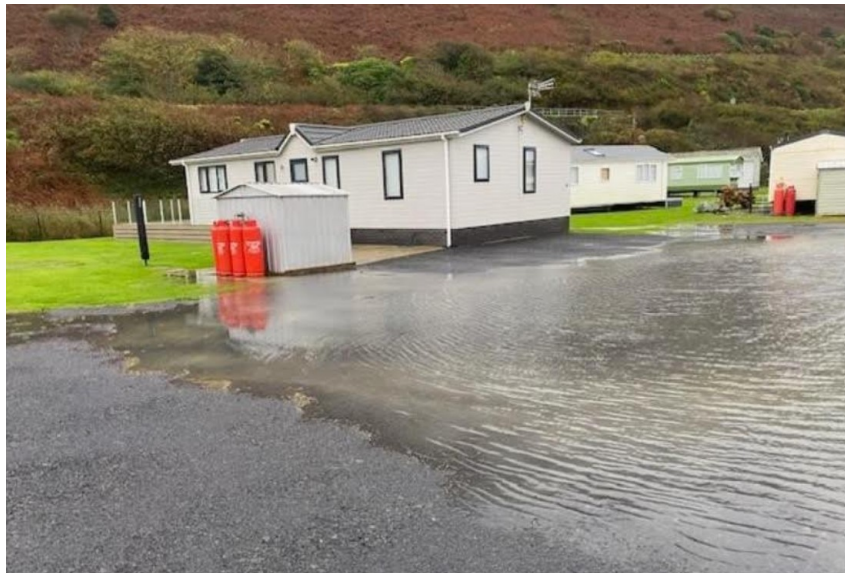
Figure 30:

During October 2023, after completion of the sheet steel piling, further flooding occurred in the central area of the caravan park (fig. 30). It is uncertain whether groundwater reached this area around the northern or southern ends of the line of piling, or whether groundwater was able to flow beneath the piles in the central area of the site.

Tidal flooding of the central area of the caravan park, October 2023.

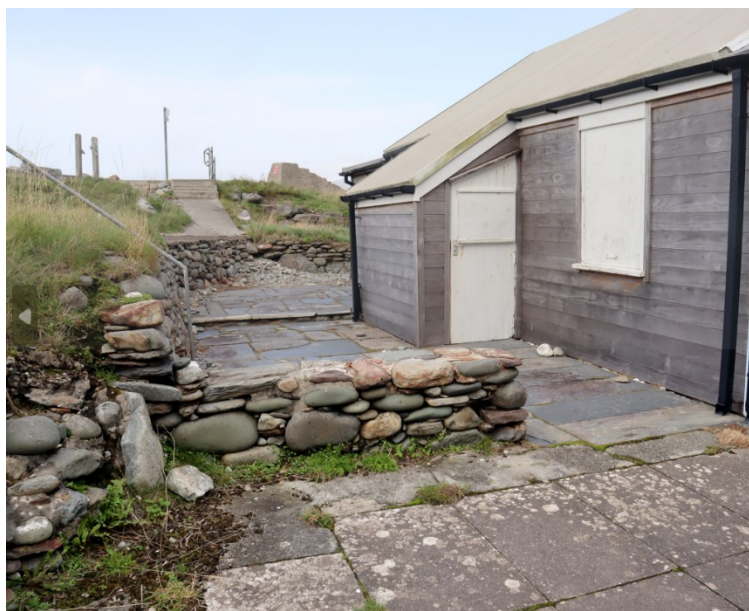
Figure 31:

The situation at the south end of the site around the line of huts is more serious, where the structure of the natural shingle spit has been severely compromised at Friog corner on both the landward and seaward sides.

Rear of the huts at Friog, showing the substantial excavation of the landward slope of the shingle spit at this point.

It is understood that the huts were built before the Second World War to provide accommodation for railway workers. To do this, a substantial amount of shingle was removed to create a flat area for the hut foundations (fig.31).

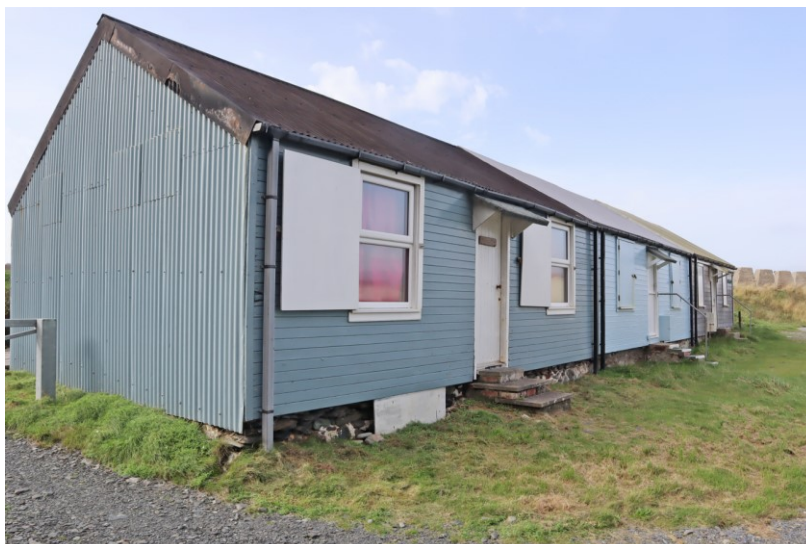
Figure 33:

The huts are of light wooden construction (fig.33). They could be moved either by jacking up the base and moving the structure on rollers or trucks, or lifted with a crane. The huts could be repositioned on the existing parking area near the railway bridge.

Huts at Friog corner.

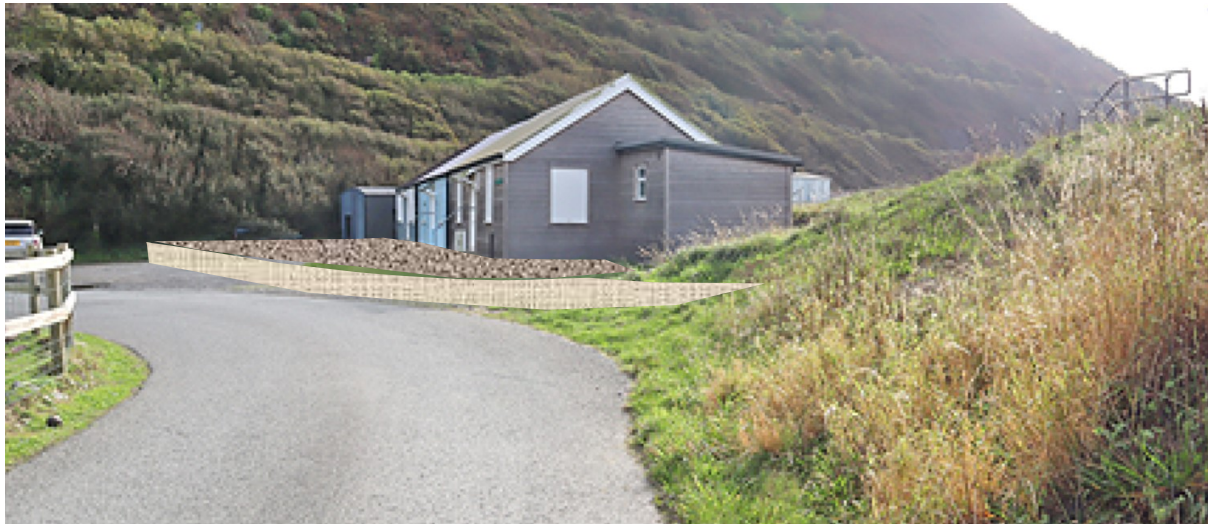
Figure 34: Huts at Friog corner after emplacement of sheet steel piles.

If arrangements cannot be made to move the huts, a less satisfactory alternative plan would be to extend the line of sheet piling across the car park in front of the huts, at a height of about 1.5m above the current ground surface (fig.34).

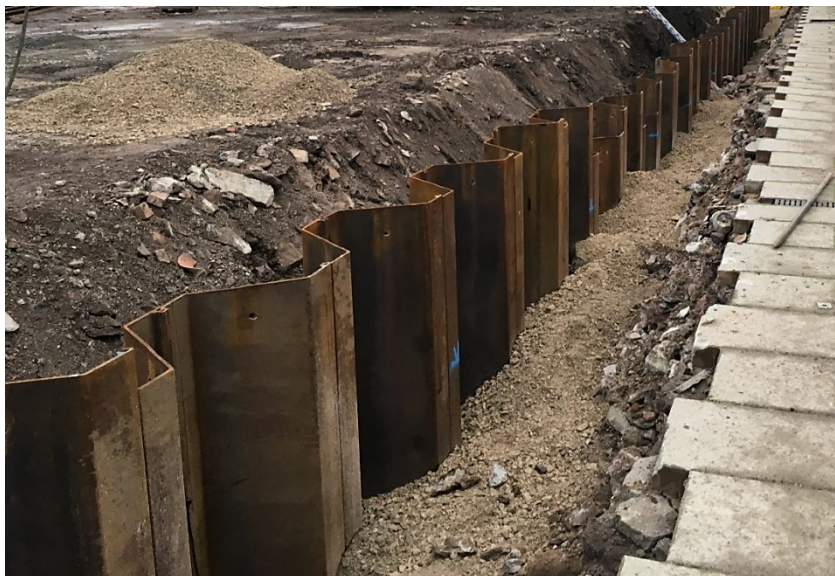
Figure 35:

Sheet steel piles of the type proposed for use at Friog corner.

After emplacement of steel piles (fig.35), the steelwork can be concealed by a low stone wall, and the ground between the pile line and the huts made up with slate waste or gravel.

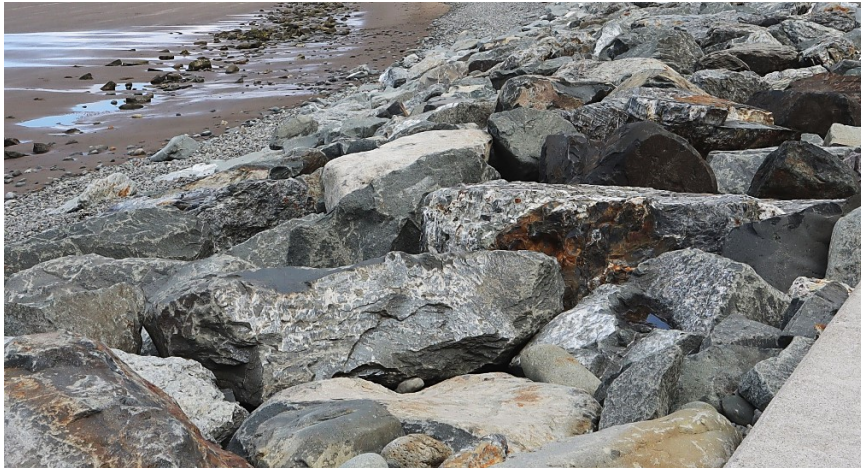
Figure 36:

It is evident that sea water can easily enter voids between the large boulders (fig.36). At times of south westerly gales at high tide, waves are likely to reach the top of the rock armour slope and will fill interconnected channels through the boulder pile, producing about 5 metres of hydrostatic pressure in excess of the tidal level.

Boulders forming the rock armour in front of the caravan park.

To reduce the occurrence of flood events at Friog caravan park, it is recommended that an attempt is made to return the rock armour to a more natural state. This could be done by tipping a layer of beach sand onto the top of the boulder slope, followed by a layer of shingle. This material should stay in place, as the unsupported rest angles for sand and shingle slopes are both higher than the 20° slope of the rock armour.

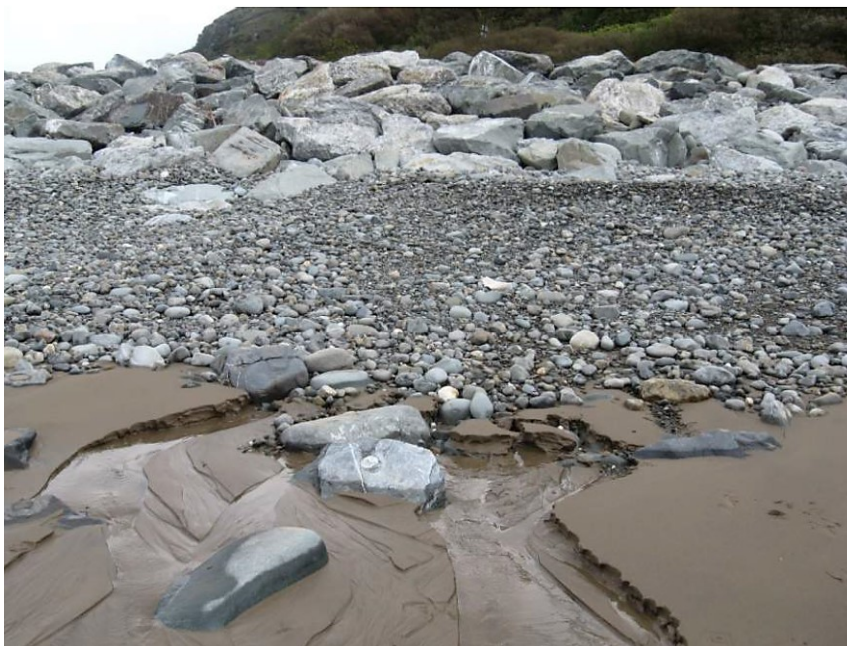
Figure 37:

Hydraulic overpressure is demonstrated by the active flows of water leaving the base of the rock armour as the tide falls (fig.37).

Substantial water flow from the base of the rock armour as the tide falls.

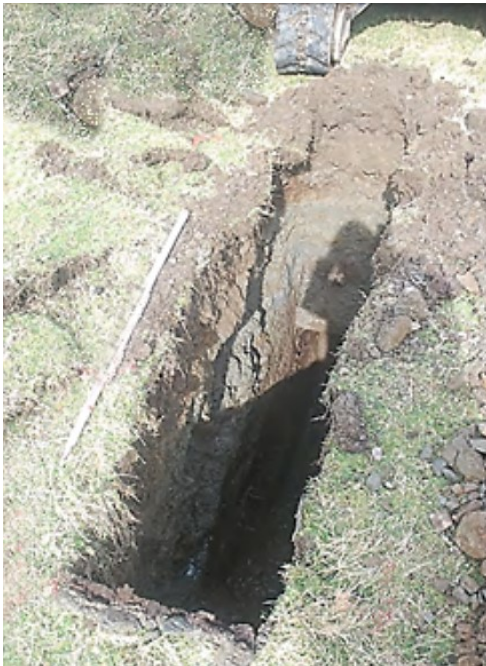
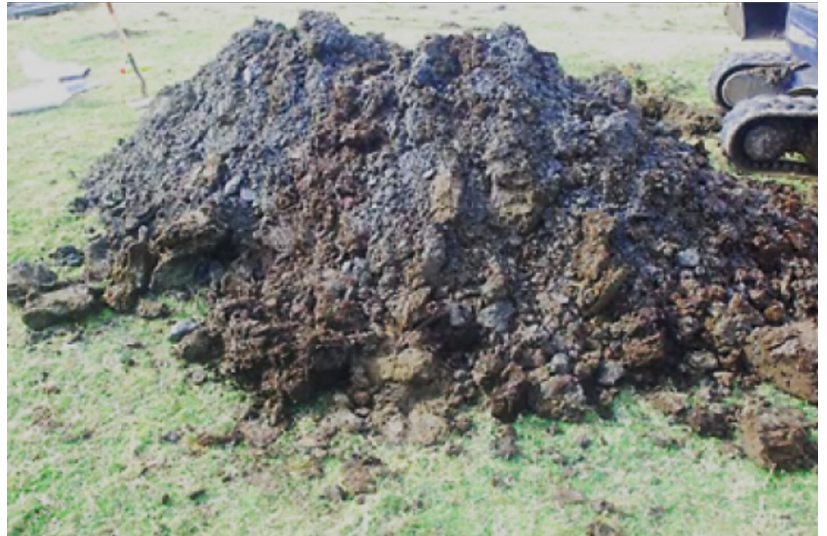
Investigations were carried out by Gwynedd Archaeological Trust (2010) in the Friog area. Excavated pits found typical estuarine deposits of peat, sand and clay. These materials are roughly layered, with organic peat content reducing with depth. The deposits have a greater sand content near the surface, being replaced by clay below a depth of one or two metres.

Figure 38: Sediments sampled at Friog. The excavated material shows a mixture of orange-brown sand and grey clay.

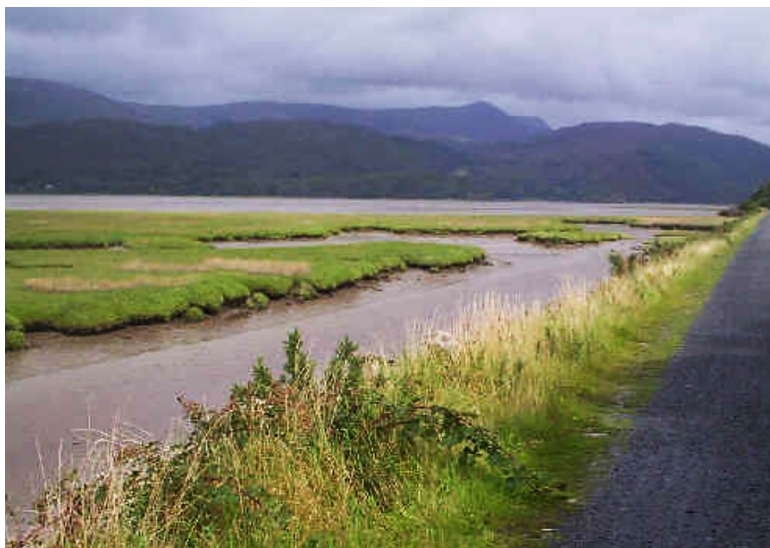
Figure 39:

Present day depositional environments in the Mawddach estuary. Salt marsh vegetation is cut by a complex pattern of channels through sand, with mud deposited on the channel floor.

The environment of deposition of the sediment sequence is typical of the Mawddach estuary at the present day. The dynamic depositional environment creates a pattern of moving channels, interspersed with salt marsh vegetation which can provide an organic peat input to sediments. Sinuous zones of sand and mud occur alongside, above and below one another.

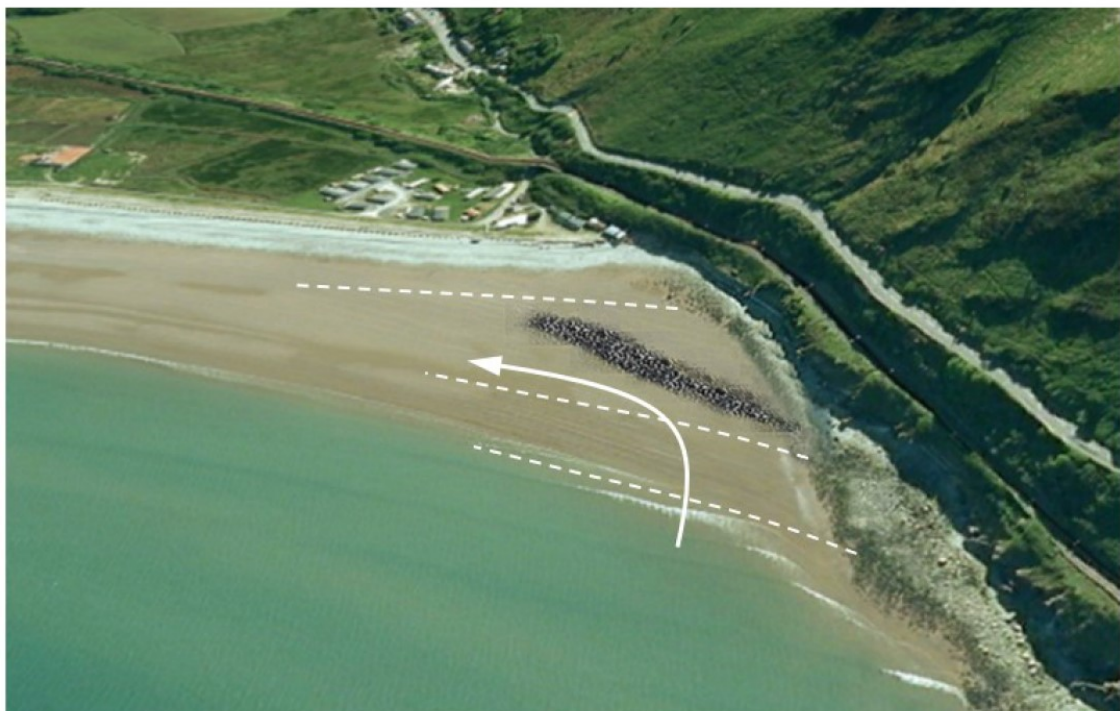
It is suggested that an inshore reef of rocks or concrete blocks is constructed at Friog (fig.40). This would deflect waves and reduce damage to the new sea defences during major storms.

Figure 40: Proposed artificial reef to deflect storm waves at Friog corner.

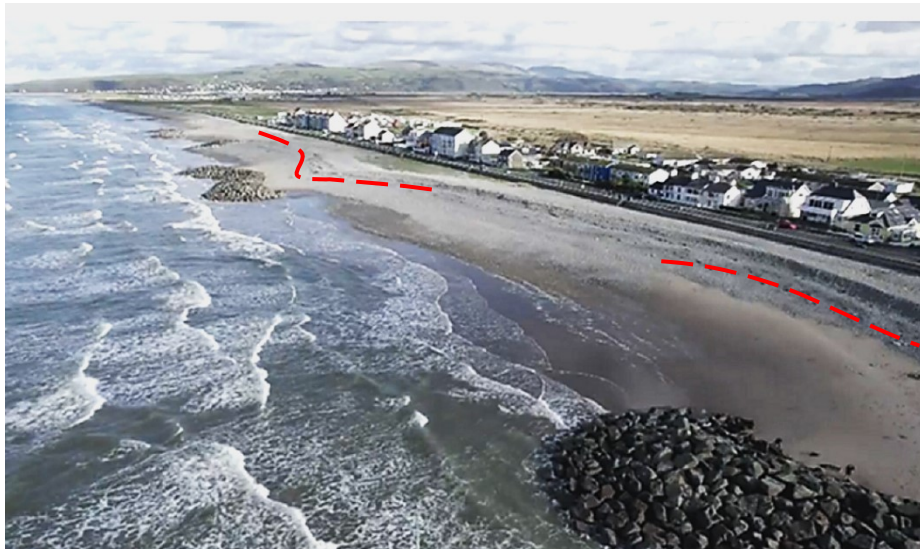
Figure 41:

Inshore reefs of boulders have been emplaced at the nearby coastal town of Borth (fig.41) as part of a coastal flood protection scheme. It is seen that shingle is accumulating behind the reef structures. In time, it is likely that shingle ridges will extend all the way to the reefs.
